# Service Bulletin

## PRELIMINARY INFORMATION

**Subject:** EBCM Wheel Speed Sensor Diagnostic Aid for ABS Message - Click Or Ratchet Noise - Service Traction Message - Service Stabilitrak Message - Service Steering Message

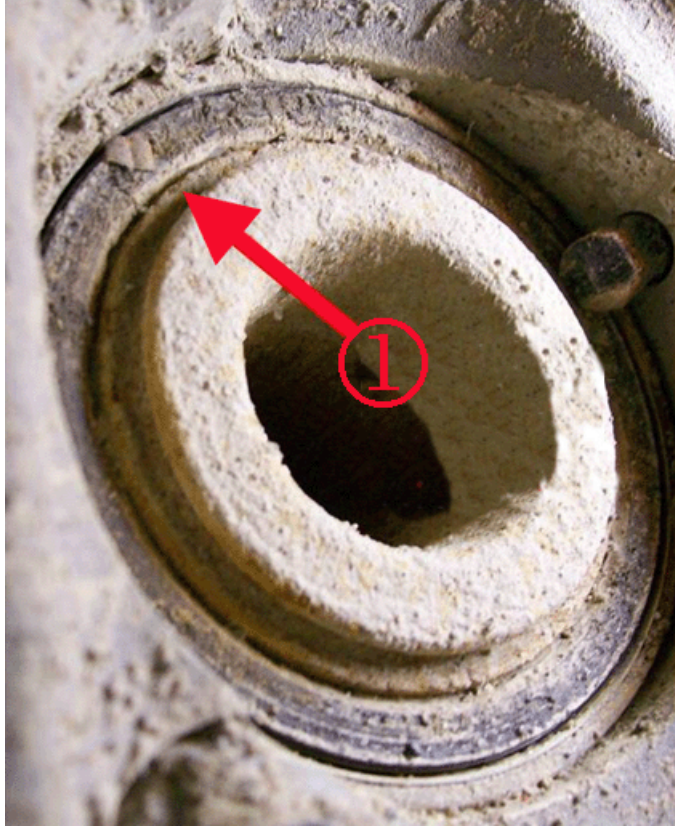
### BEFORE CLEANING

These conditions may be caused by single or multiple pieces of ferrous metallic debris stuck to the wheel speed sensor magnetic encoder ring. This magnetic encoder ring is now part of the inboard bearing hub assembly.

(1.) Sample Debris

1. Based on the specific EBCM module Wheel Speed Sensor DTC code; inspect the appropriate corner magnetic encoder ring for possible debris.
  - C0035 Left Front Corner
  - C0040 Right Front Corner
  - C0045 Left Rear Corner
  - C0050 Right Rear Corner

2. If debris is found, perform the following cleaning recommendations.

- 2.1. Gently using a dry nylon soft bristle brush, remove the foreign debris off the magnetic encoder ring. If debris was removed, proceed to step 3.
- 2.2. If debris still remains, wash the encoder ring using a mild soap detergent and wipe dry.
