# Service Bulletin

**Subject:** Service Stability, Traction, ABS Rear Wheel Speed DTC Or Chassis Expansion And High Speed Bus Communication Fault

**Models:** 2010 - 2013 Chevrolet Equinox

2010 - 2013 GMC Terrain

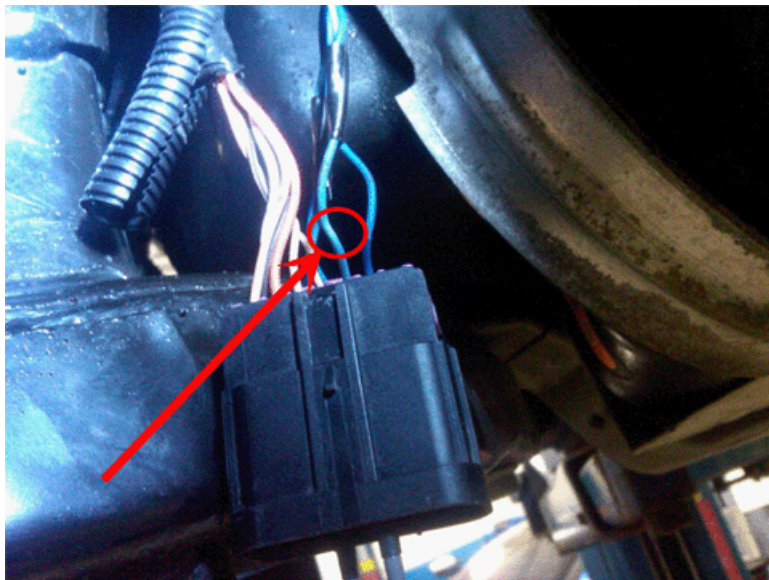
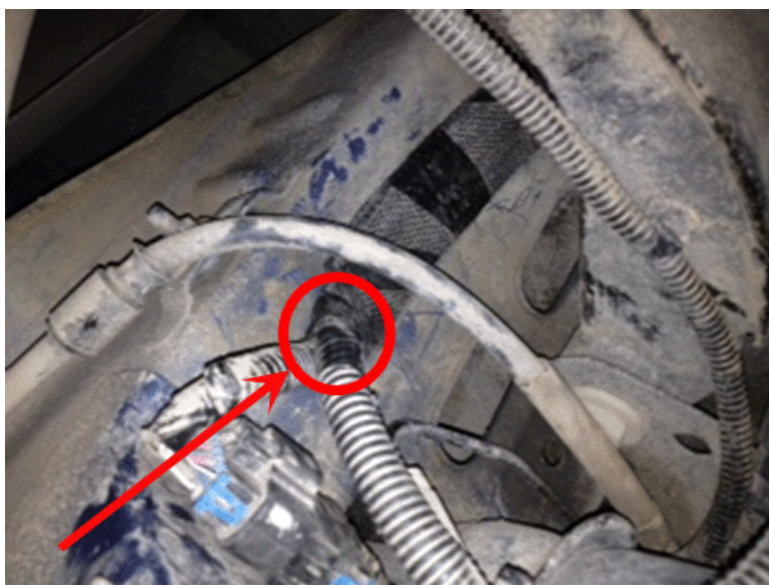
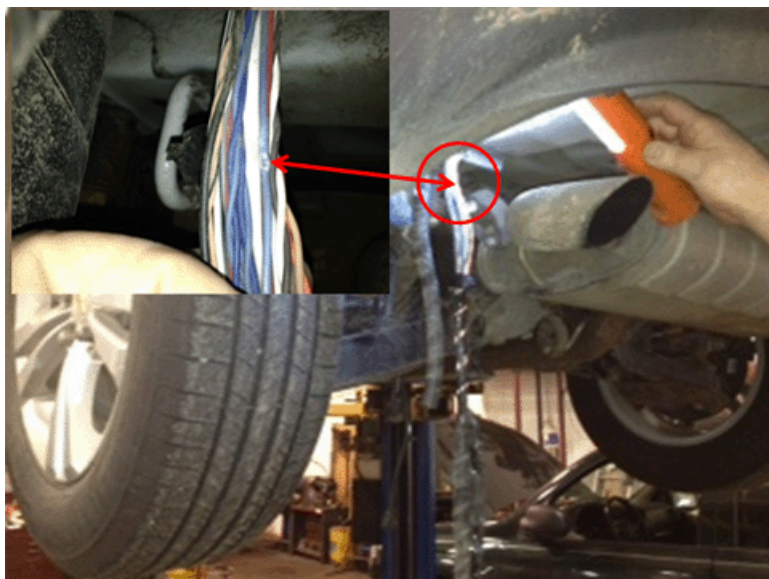
**Note:** Wire broken within the insulation has also been found high up in the harness X411 it will be necessary to lower the harness to gain access. Reference the following photos:

Several conditions and symptoms have been found to be related to a wire harness at the left rear under vehicle. Inspect the wire harness insulation within 1 inch of the X411 before and after connector. It may be necessary to remove the tape and conduit from the wire harness for inspection upstream from the X411 connector. Some Issues have been found with circuits 6105 and 6106 for chassis bus wires and serial enable circuit 5986 and 120 ohm opens in 2500 and 2501 or 6106 and 6106. Other circuits 884, 885, 882, and 883 when related to rear wheel speed sensor codes C0045 or C0050. During inspection you may notice chewed up conduit or a discoloration in insulation in one spot of the wire. If you pull the wire near that area the insulation it will break exposing the broken wire and possible corrosion or rodent damage. Repair the circuit to complete the procedure.

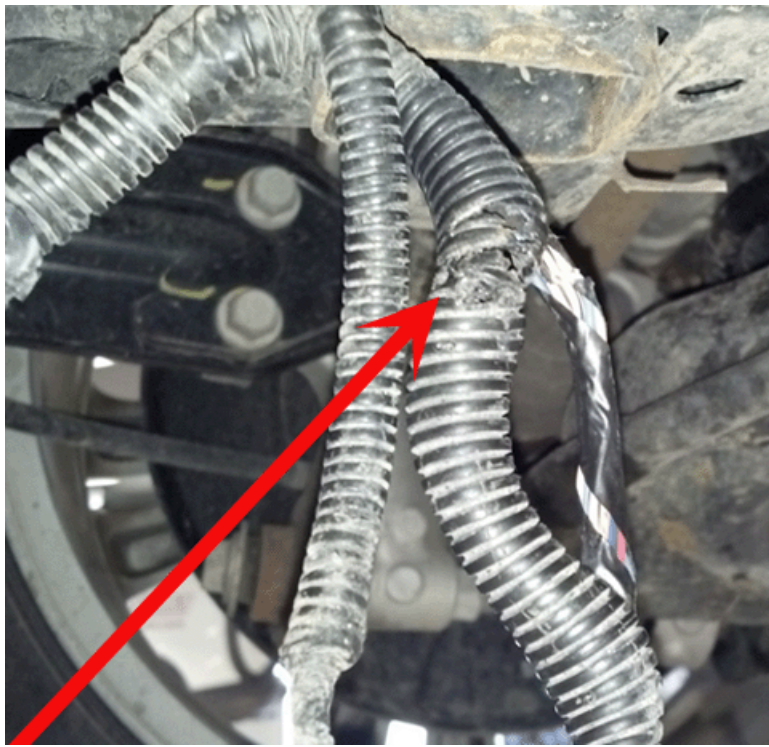
Damaged conduit

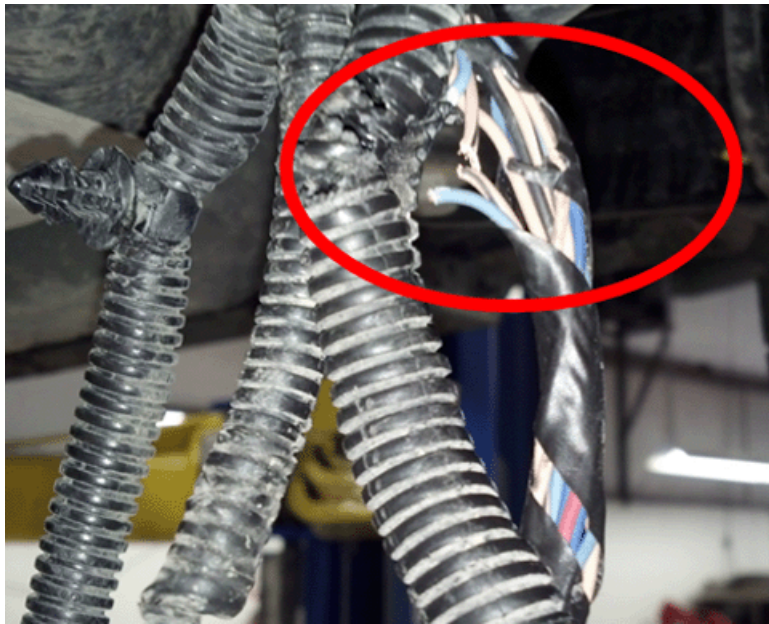
Wires chewed through
