# Service Bulletin

**Subject:** SES Lamp On With DTC P2270

**Models:** 2013 Chevrolet Silverado

2013 GMC Sierra

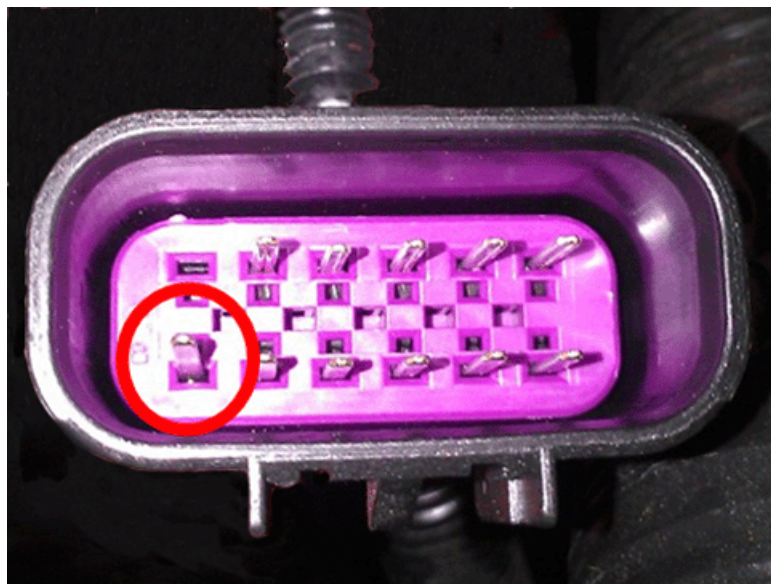
Concern of DTC P2270 setting along with any of the following codes P0140, P0139, P0138, P0137, P013A, P013B on vehicles built at the Fort Wayne and/or Silao assembly plants during January or February of 2013.

Check connector X131 for a bent terminal F as indicated in the attached PIC and repair per SI procedures.

If no connector issue is found, follow SI diagnostics.
