# Service Bulletin

**Subject:** SES Lamp P0300 P0351 - P0358

**Models:** 2014 Chevrolet Silverado 1500

2014 GMC Sierra 1500

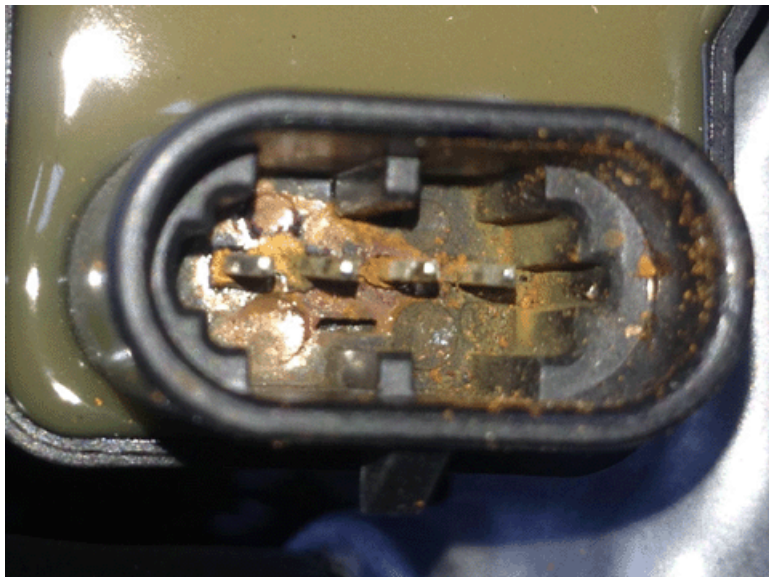
Inspect the coil connectors for a clear water and/or a discolored connector.

Picture of a coil with the concern:

If this is found inspect the pigtail for pin drag or loose terminals (repair as needed).

Swap the coil to a known good location.

If the concern follows the coil replace the coil or coils with the concern and add dielectric grease to the connection.
