# Technical Service Bulletin

## 87 Various HVAC system malfunctions, DTC B11AF07 and/or B109207 stored in the climatronic module or the BCM 1

87 19 02 2055257/4 December 9, 2019. Supersedes Technical Service Bulletin Group 87 number 19-01 dated December 3, 2019 for reasons listed below.

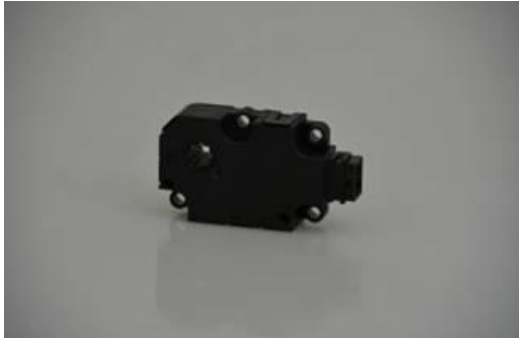
| Always check with your Parts Department and/or ETKA for the latest information and parts bulletins. | | |
|---|---|---|
| 4M0820511A | <br>Motor for adjustment | As necessary |

In cases where the HVAC adjustment motor needs to be replaced, install the HVAC adjustment motor with the part number 4M0 820 511 A.
