## Technical product information

| <b>Topic</b> | Mulsanne - Camshaft Position - Diagnostic Trouble codes |
| <b>Transaction No.</b> | 2057991/1 |

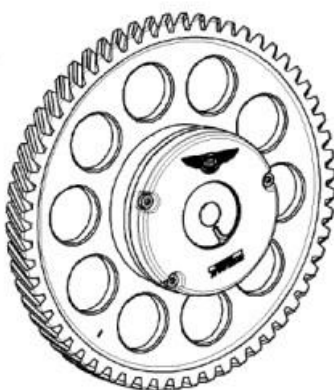
When the engine is cold increased friction within the camshaft adjuster unit may result in "*camshaft position*" DTC's being stored within the ECU. The concern can be resolved by replacing the camshaft timing gear with a "B" level part which utilises an internal return spring with higher rate. See *Parts information* below.

With a confirmed customer complaint of uneven engine running and camshaft position DTC's stored within the ECU, replace the camshaft timing gear with a "B" level part.

Refer to *Repair Group - 15 Engine cylinder head, valve gear / Camshaft / Timing gear – to replace*.

When all work is complete conduct at least one "cold start" and two drive cycles prior to handing the vehicle to the Customer.
