# Technical product information

| Topic | TPMS Warning light - DTC U012700 evident |
| Transaction No. | 2057947/1 |

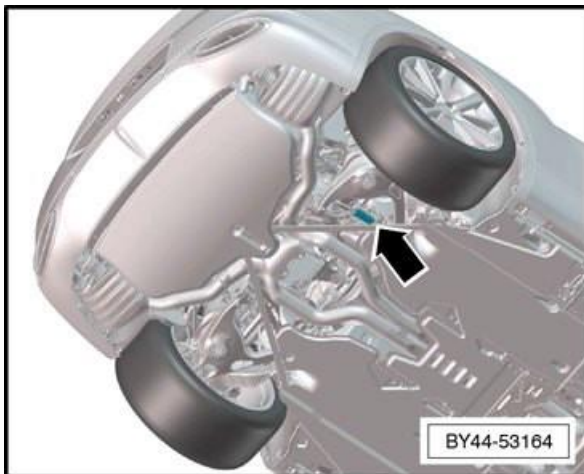
Tyre pressure monitoring system warning light on within the DIP

DTC U012700 evident within Address 0019 Gateway

NOTE: For clarity Figure 1 shows the fitting location for the New Continental GT, New Continental GTC and New Flying Spur, Figure 2 shows the fitting location for Bentleyga

1) Replace the Tyre pressure control module and bracket (Figure 1) - Refer to Rep.Gr 44

The control module and bracket should be returned back to Bentley Motors Crewe as a complete assembly using the normal parts return procedure
