## Technical Service Bulletin

| <b>Topic</b> | HVAC operation issues/HVAC Motor defect DTC's logged |
| <b>Brand</b> | Bentley |
| <b>Transaction No.</b> | 2051519/5 |

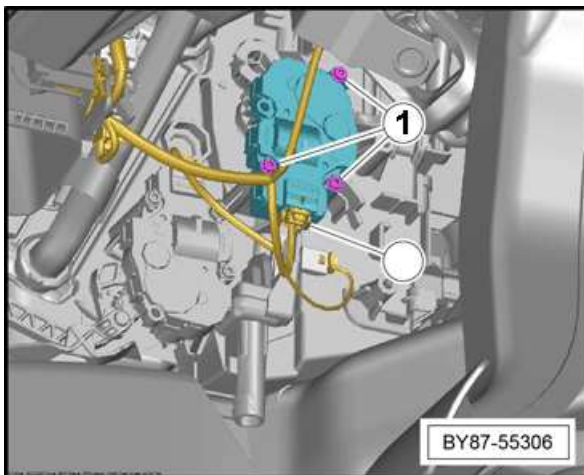
The servomotor can become jammed causing HVAC operation issues.

Figure 1 - Right foot well temperature flap motor (V581) is shown as an example only

1. Lightly tap the casing of the motor with, for example, a handle from a screwdriver then erase the DTC.
2. If the DTC erases, carry out basic settings of the HVAC control module then recheck for DTC's. If the DTC does not erase or returns then continue to point 3
3. Remove fixings which secure the motor to the HVAC unit

4. With care attempt to manoeuvre/reposition the motor (without completely removing it from the HVAC assembly)
5. Secure the fixings -1- then erase the DTC
6. If the DTC erases, carry out basic settings of the HVAC control module. If the DTC does not erase the motor should be replaced.
7. If applicable to your vehicle please ensure Service Campaign EB28 (Bentayga) or EB29 (New Continental GT/GTC) has also been applied.
