# Technical Service Bulletin

CHECK ENGINE LIGHT ON WITH DTC P2610 AND P2507

**Bulletin No.:** 01-002/20

**Last Issued:** 01/23/2020

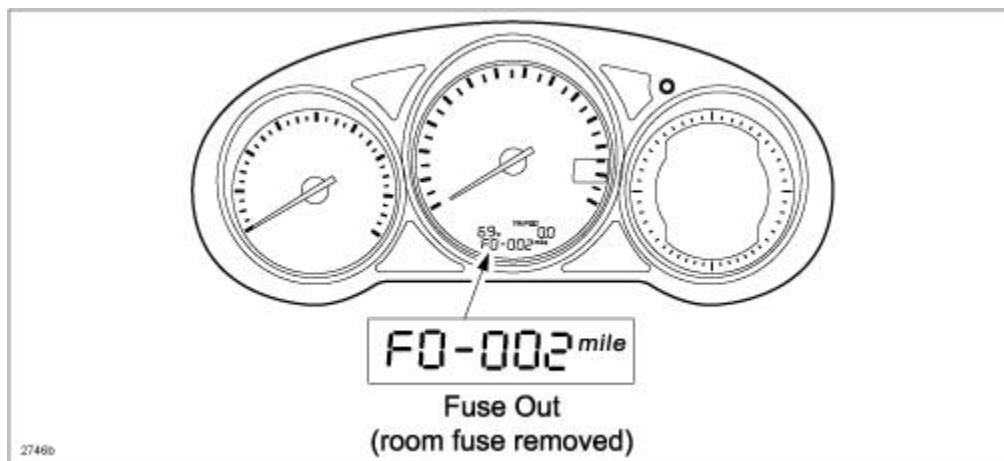
**NOTE:** The odometer will display "F0-002" during transport mode (room fuse 15A removed). Transport mode is canceled when room fuse 15A is installed or the vehicle odometer is more than 12.4mi (20km).
