# Service Update

## N192226060 High Voltage Contactors Welded in Closed Position

**Release Date:** January 2020

Subject: N192226060 - Service Update  
High Voltage Contactors Welded in Closed Position

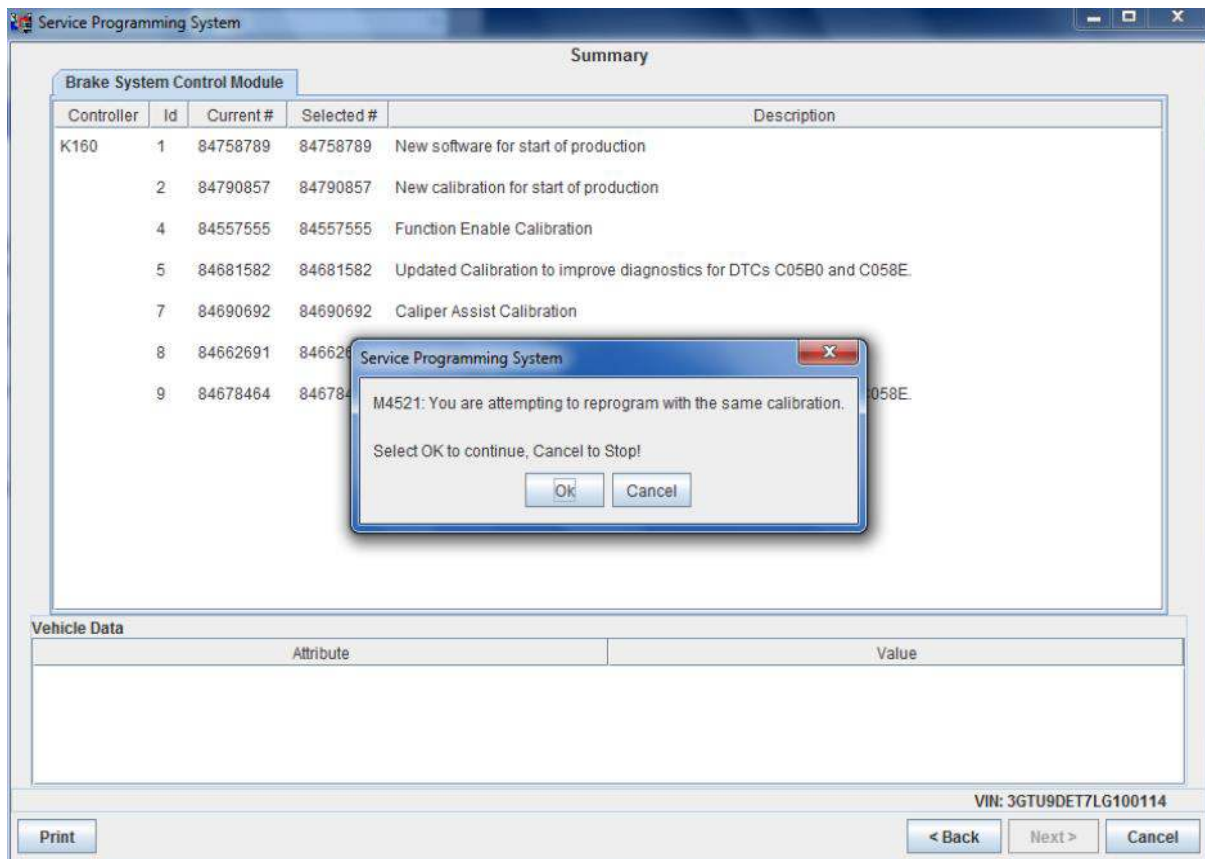
5431207

**Important:** If the Same Calibration/Software Warning is noted on the SPS screen, select OK and follow screen instructions. After a successful programming event, the WCC is located in the Service Programming System dialogue box of the SPS Summary screen. No further action is required. Refer to the Warranty section of the bulletin.

1. Reprogram the Hybrid Powertrain Control Module. Refer to *K114B Hybrid/EV Powertrain Control Module 2: Programming and Setup* in SI.

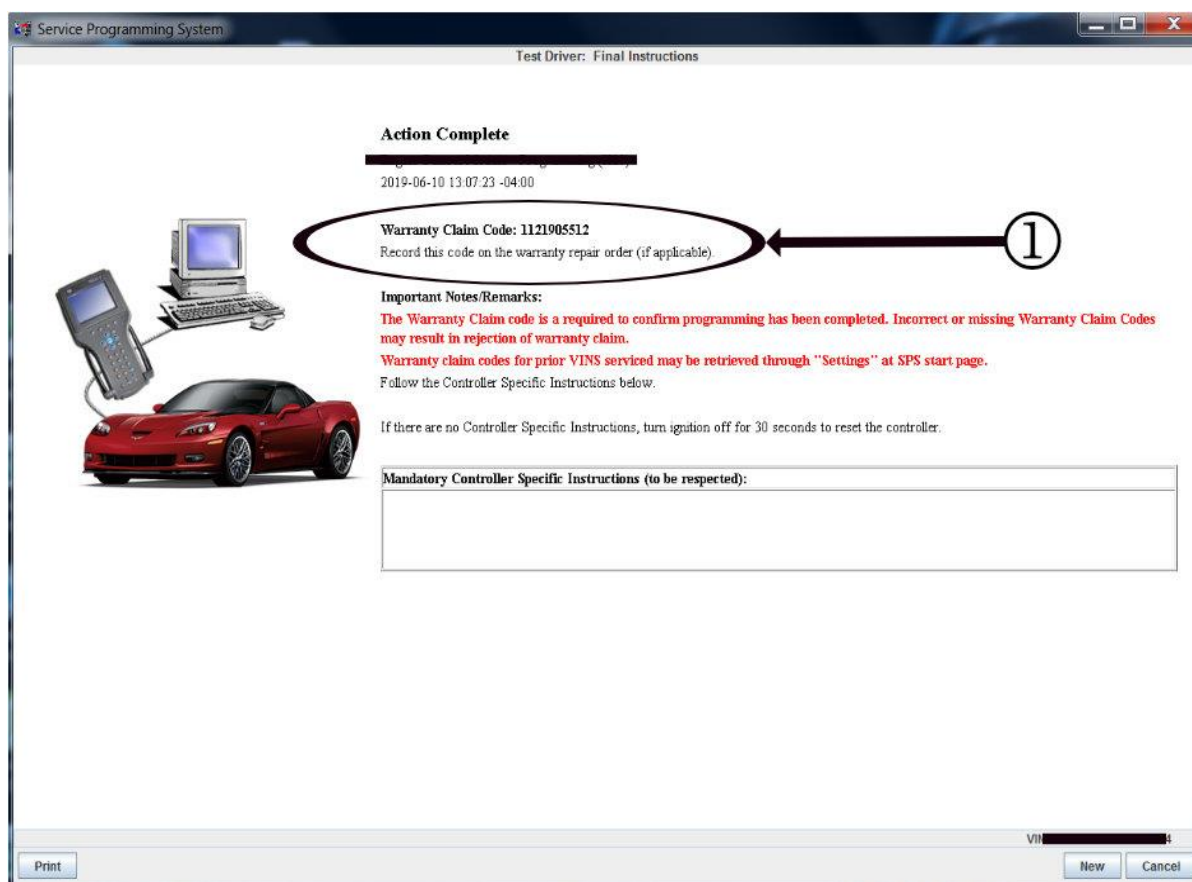
5431209

**Important:** To avoid warranty transaction rejections, you **MUST** record the warranty claim code provided on the SPS Warranty Claim Code (WCC) screen on the job card. Refer to callout 1 above for the location of the WCC on the SPS screen.

- Record SPS Warranty Claim Code on job card for warranty transaction submission.
