# Extended Crank and/or MIL ON With DTC P0171, P0174, P0172, P0175, P1604 (Flex-Fuel)

Some 2009 – 2018 model year Sequoia and 2009 – 2019 model year Tundra vehicles equipped with a 3UR-FBE engine may exhibit a hard start and/or MIL ON condition with one or more of the following Diagnostic Trouble Codes (DTCs):

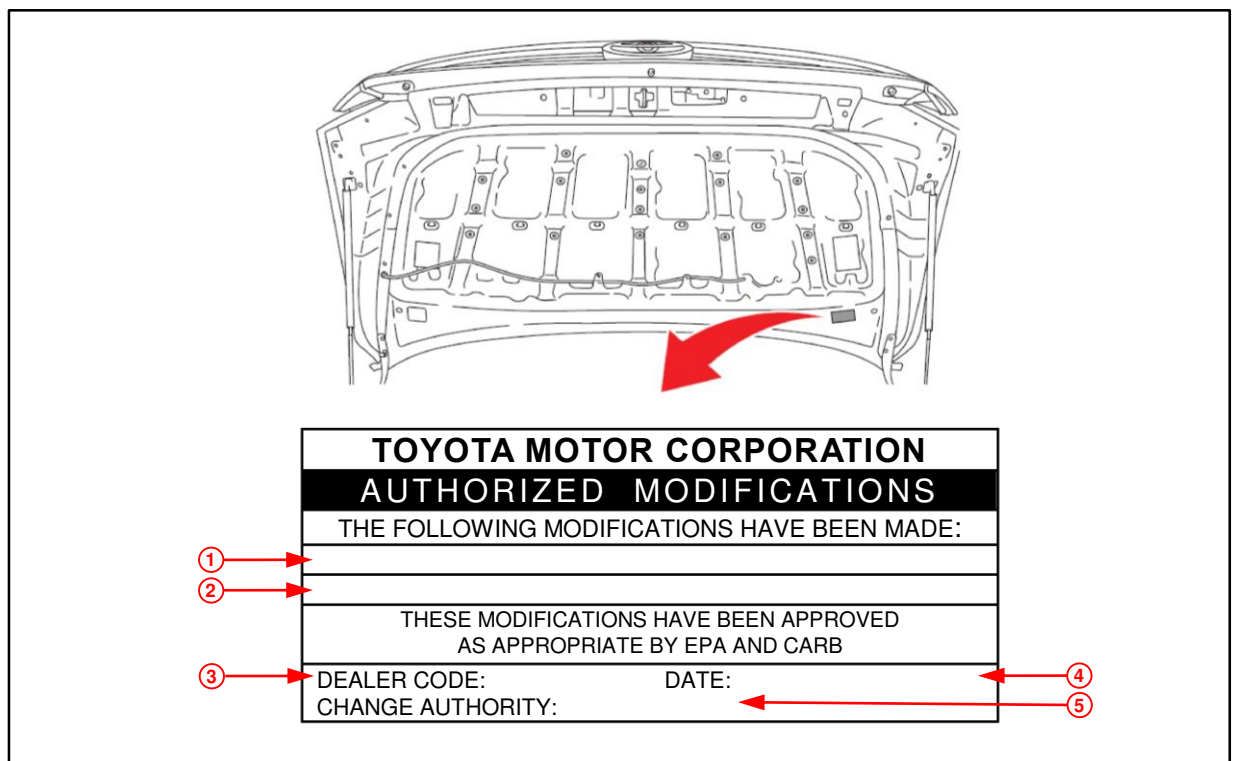
**Figure 1. Location of Authorized Modifications Label on 2009 – 2018 Sequoia and 2009 – 2019 Tundra**

3. Use Techstream to confirm if the ECM (PCM) calibration has been updated and check for the Authorized Modifications Label affixed to the vehicle in the location shown below.

##### B. Install the Authorized Modifications Label onto the vehicle at the location shown in Figure 1. The Authorized Modifications Label is available through the MDC, P/N 00451-00001-LBL.
