# Technical Service Bulletin

## 91 MIB2 High: Navigation data read error/reboots, DTC B126CF0 and/or B126CF1 stored in the information module

91 20 37 2057052/2 February 20, 2020. Supersedes Technical Service Bulletin Group 91 number 19-08 dated October 31, 2019 for reasons listed below.

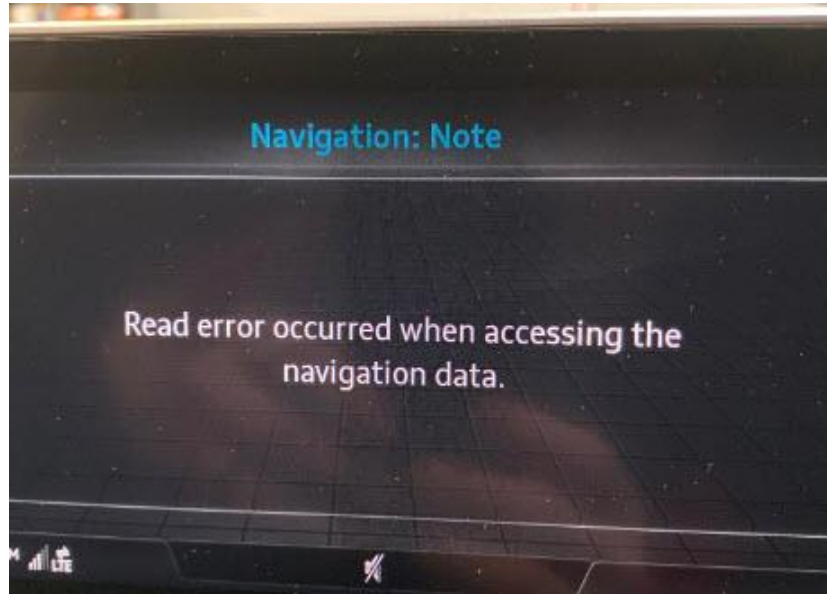
- The MMI shows the message “Read error occurred when accessing the navigation data” after initialization (Figure 1).
- The MMI reboots constantly.

**Figure 1.** The error message is shown on initialization.

If the navigation map database is corrupted during an online update, the message from Figure 1 is displayed and the navigation system is unavailable. The DTC B126CF0 is entered into the information electronics, J794 (address word 005F).

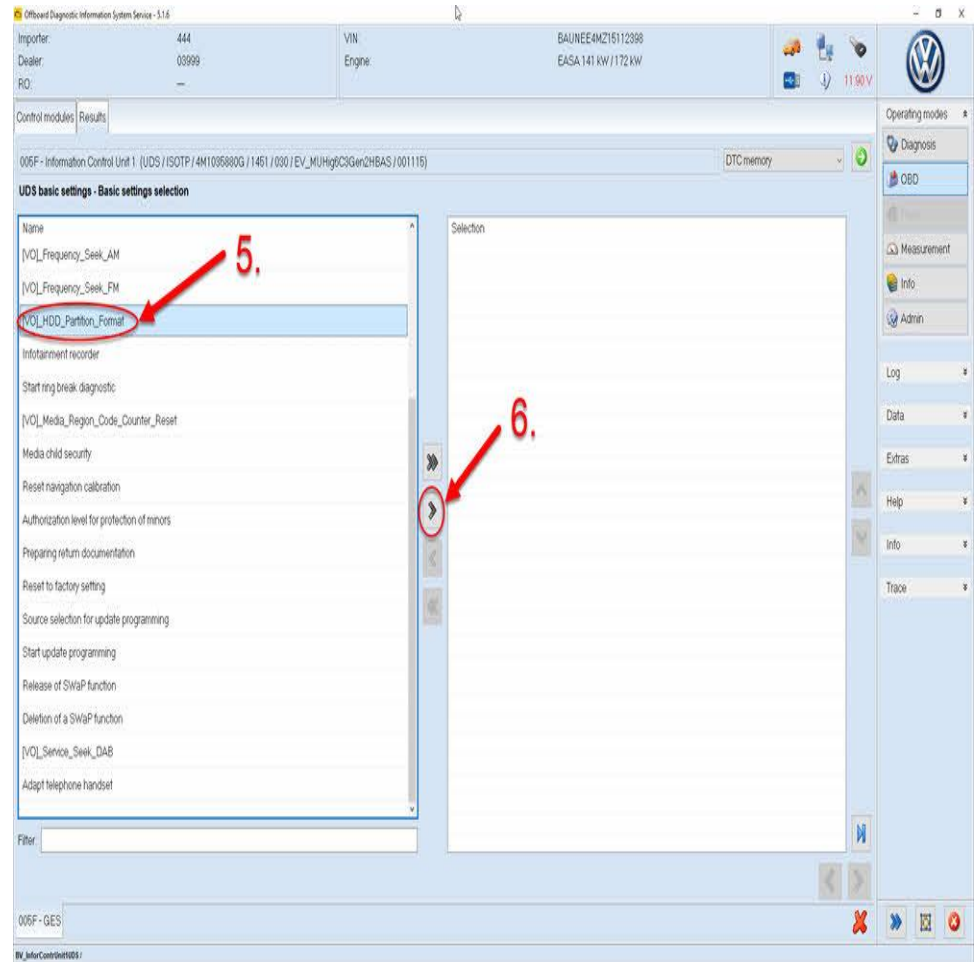
**Figure 4.** Select the basic setting.

3. In the list on the left, select "[VO]\_HDD\_Partition\_Format" (5), then click the single right-pointing arrow in the center (6) (Figure 4).

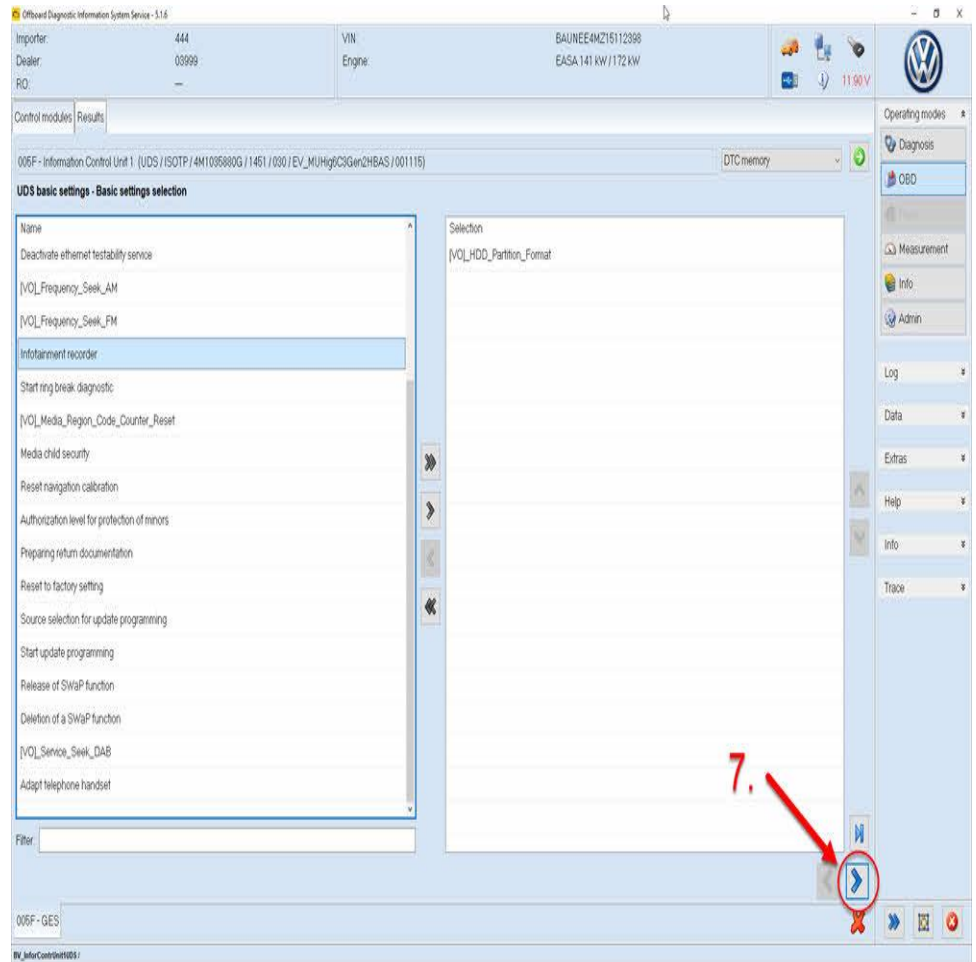
**Figure 5.** Select next.

4. Hit the “Next” button on the bottom right (7) (Figure 5).

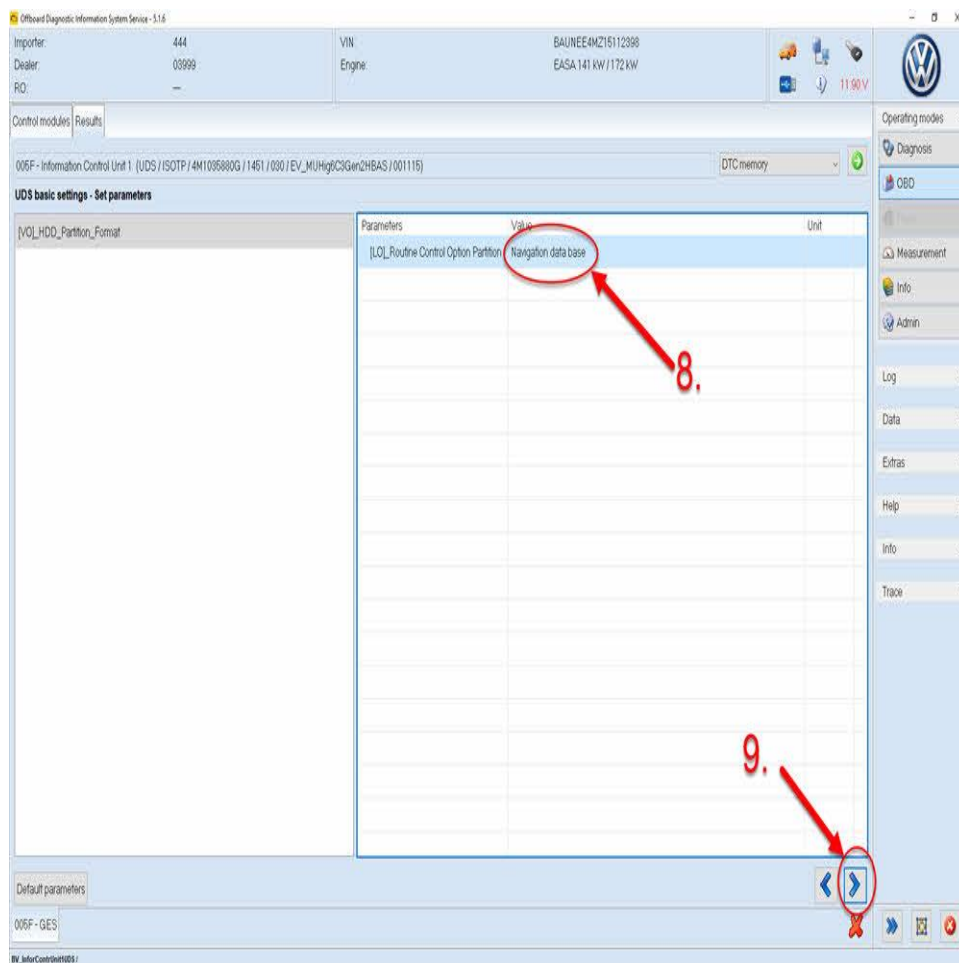
**Figure 6.** Navigation data base partition.

5. Make sure that the value for the parameter “[LO]\_Routine Control Option Partition” says “Navigation data base” (8), then click “Next” (9) (Figure 6).

**Tip:** Make sure that the “Navigation data base” is selected. An incorrect selection in this step might render the control module/unit nonviable.

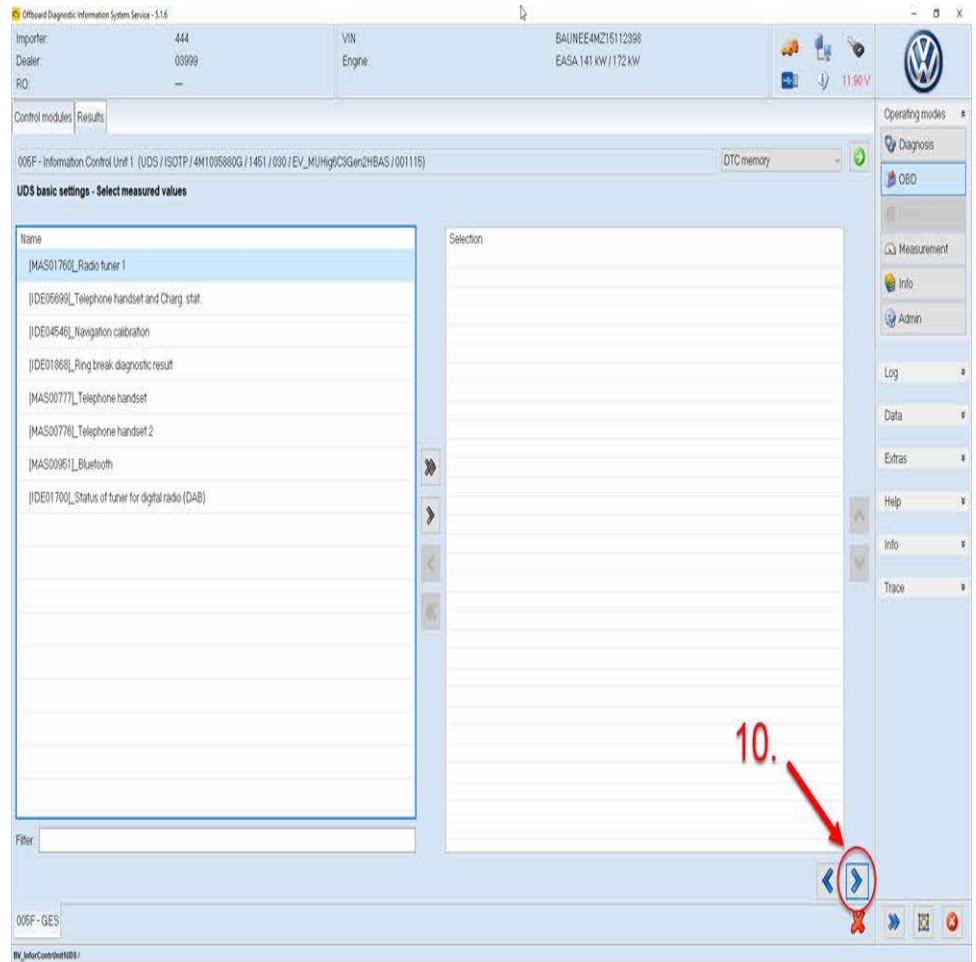
**Figure 7.** Select next.

6. Click “Next” one more time (10) (Figure 7).

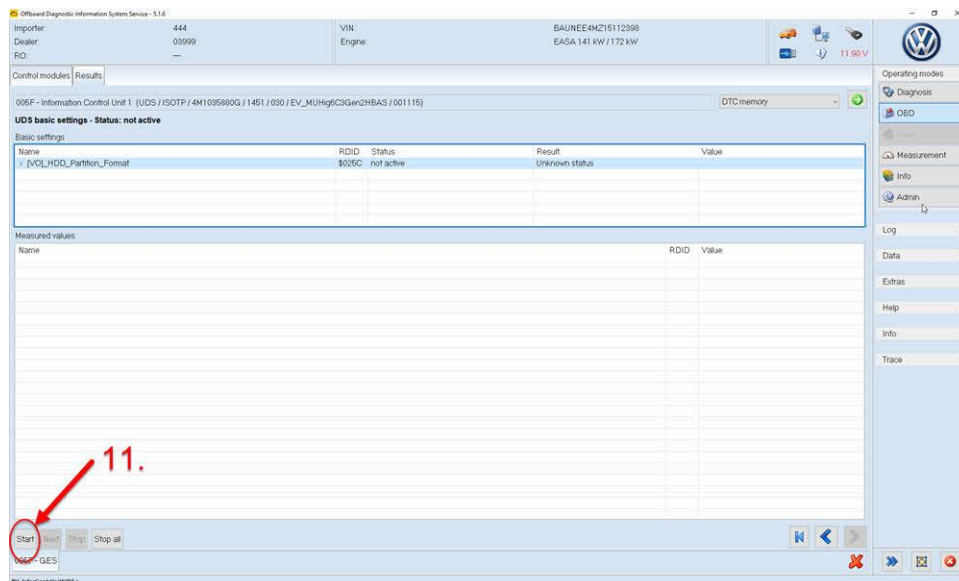
**Figure 8.** Execute the basic setting.

7. Select “Start” (11). The basic setting should complete within a few seconds (Figure 8).
