## Technical product information

| <b>Topic</b> | New Continental GT/GTC - Additional Cooling Pump - Diagnostic Trouble Code |
| <b>Transaction No.</b> | 2058340/1 |
| <b>Release date</b> | 11-Feb-2020 |

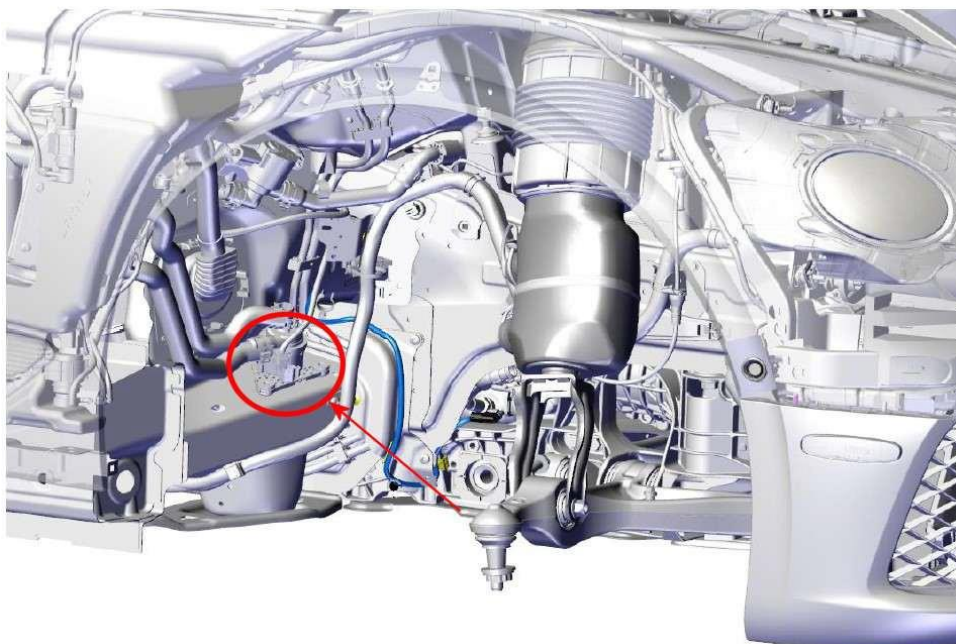
Figure 1

The "Additional Coolant Pump" is located at the rear of the right hand front wheel arch – figure 1.
