MODEL  
**2017-2020MY  
Niro (P/HEV)**

NUMBER  
**PS647**

### ENGINE ELECTRIC WATER PUMP (EWP) CONNECTOR AND PIGTAIL ISSUES FOR DTC U045600

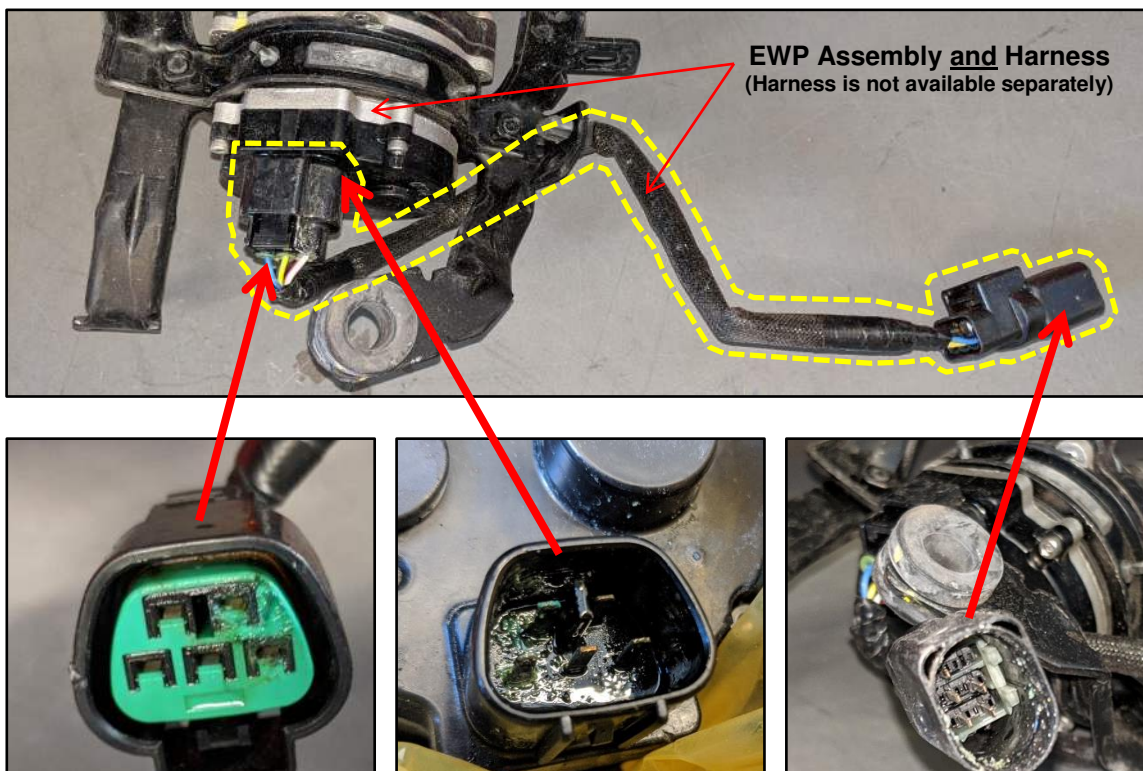
This Pitstop provides information regarding DTC U045600 on some 2017-2020 Niro (P/HEV) vehicles, which may set due to the EWP and/or harness connectors (C102) being contaminated with coolant. In the event that this DTC is set, thoroughly inspect the EWP and harness connectors which are located behind the Engine Coolant Temperature Sensor (ECTS) and are sometimes difficult to see.

#### DTC U045600: Invalid Data Received from Coolant Temperature Control Module

Note: In some instances the Module 8 fuse and the EWP fuses will be blown as a result of the coolant contamination. Be sure that both fuses are checked for continuity after replacing the EWP and short harness. Note: Harness is not sold separately, however it is included with a new EWP assy.
