| <b>HYUNDAI</b><br><b>Technical Service Bulletin</b> | GROUP<br><b>CAMPAIGN</b> | NUMBER<br><b>20-01-005H</b> |
| | DATE<br><b>February, 2020</b> | MODEL(S)<br><b>SONATA (DN8)</b> |
| <b>SUBJECT:</b> | ECM SOFTWARE UPDATE – GDI P0456 (SERVICE CAMPAIGN T4N) | |

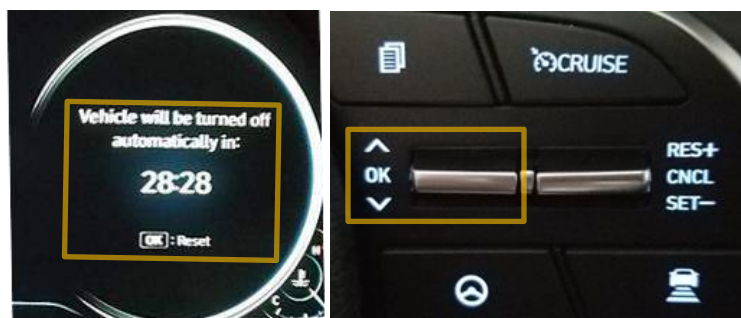
The ECM Software Update takes approximately 15 minutes to perform. However, the vehicle is equipped with a 30 minute factory default Vehicle Auto-Shut Off feature.

If the **Vehicle Shut-Off Timer: XX:XX** appears on the cluster, press **OK** on the steering wheel to reset the timer before starting the ECM update.

In the event of ECM update failure due to Vehicle Auto-Shut Off activation, perform the ECM update again in the **Manual** mode.
