# Service Bulletin

Bulletin No.: 20-NA-015

**Subject:** Runs Rough Cold or Stall Condition Upon Cold Start and/or DTC U18A2 Set (Mexico Only)

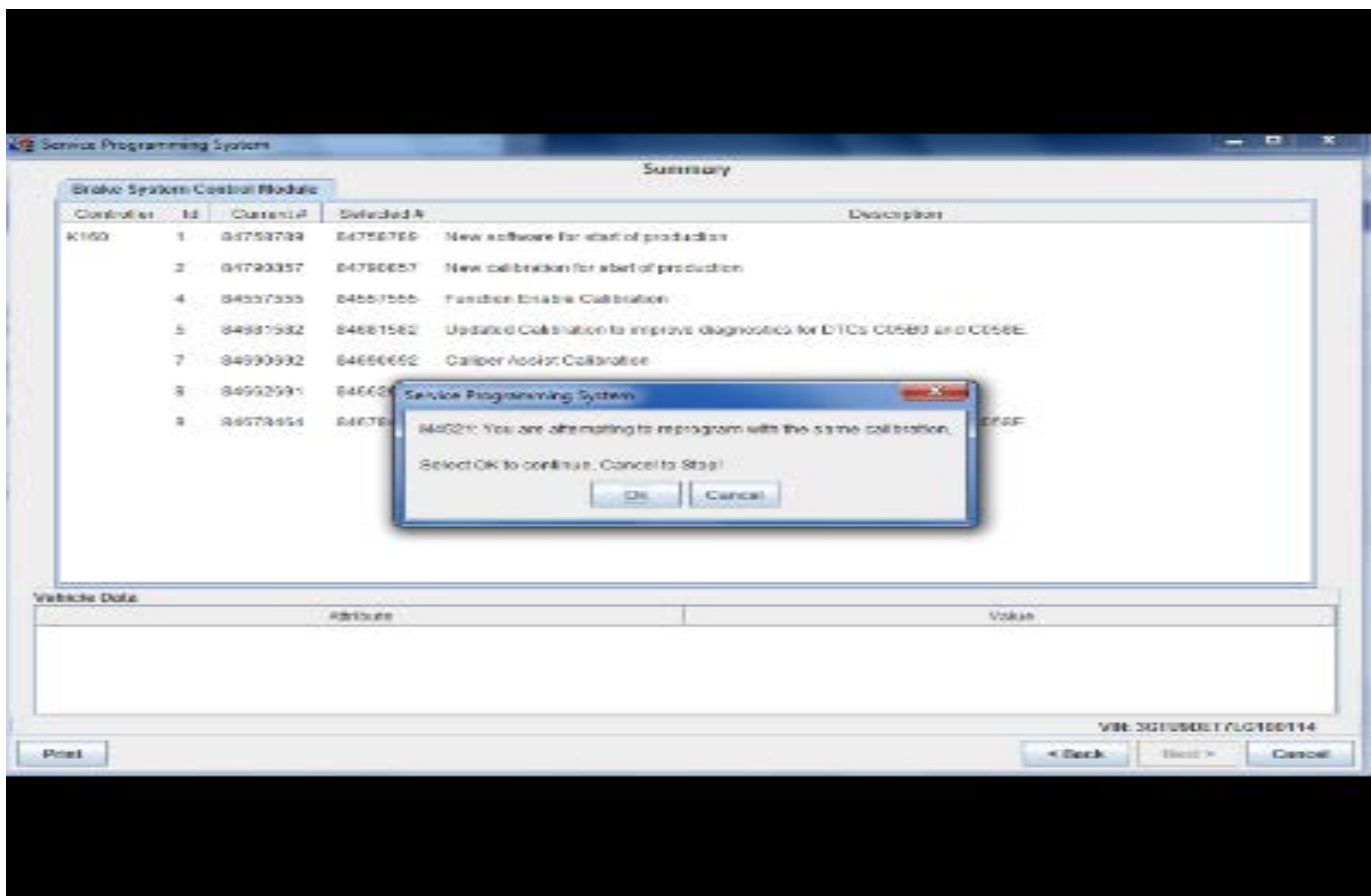
5431207

**Important:** If the Same Calibration/Software Warning is noted on the SPS screen, select OK and follow screen instructions. After a successful programming event, the WCC is located in the Service Programming System dialogue box of the SPS Summary screen. No further action is required. Refer to the Warranty section of the bulletin.

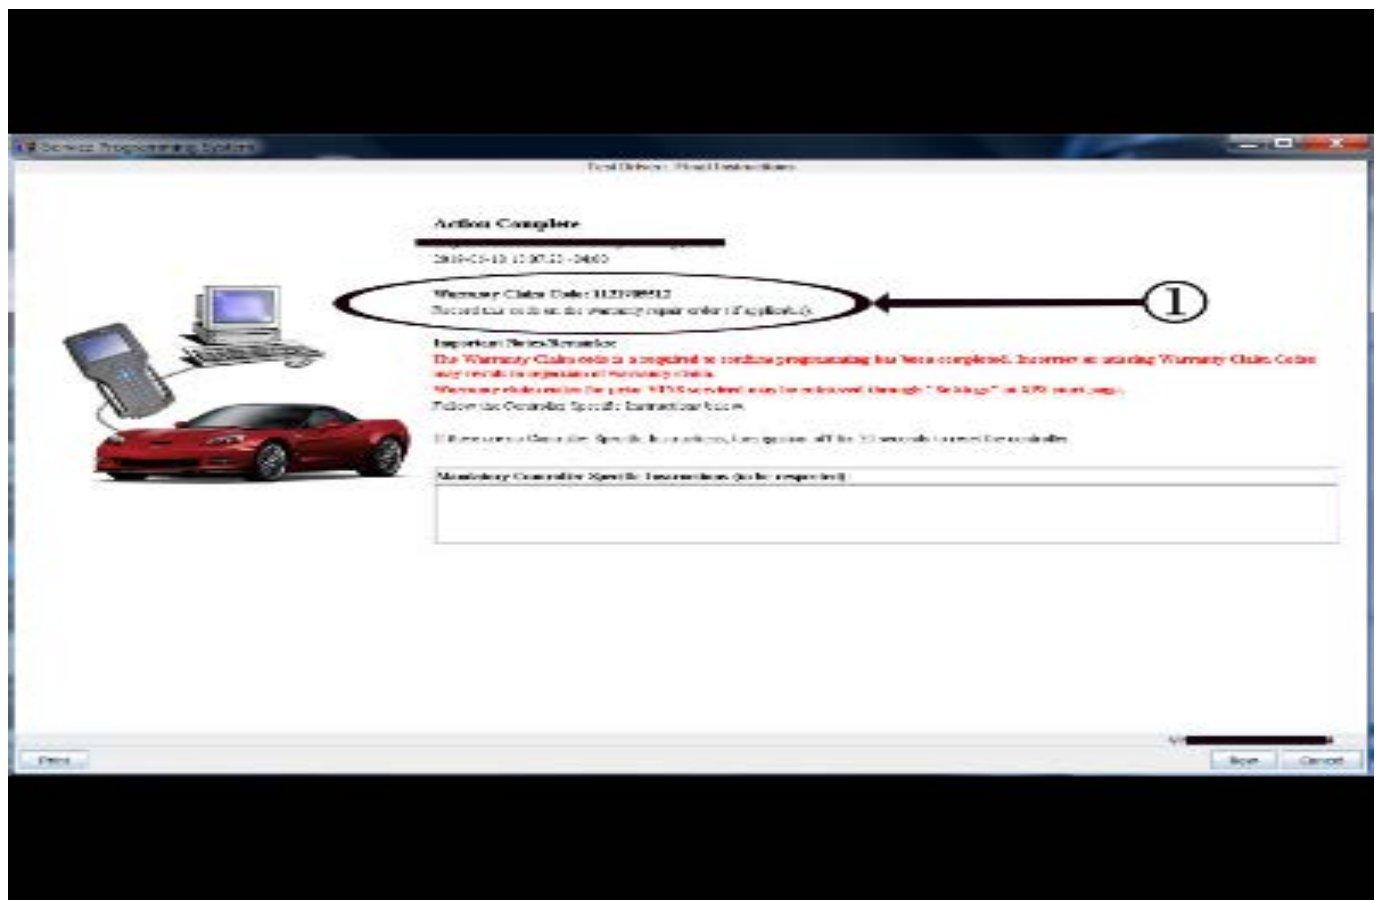
5431209

**Important:** To avoid warranty transaction rejections, you **MUST** record the warranty claim code provided on the SPS Warranty Claim Code (WCC) screen on the job card. Refer to callout 1 above for the location of the WCC on the SPS screen.

- 2. Record SPS Warranty Claim Code on job card for warranty transaction submission.
