Preliminary Information

PIP5495L Check Engine Light On With P0299 Or P0234

| Cause: | Misdiagnosis Leading to Returned Turbochargers with NTF |

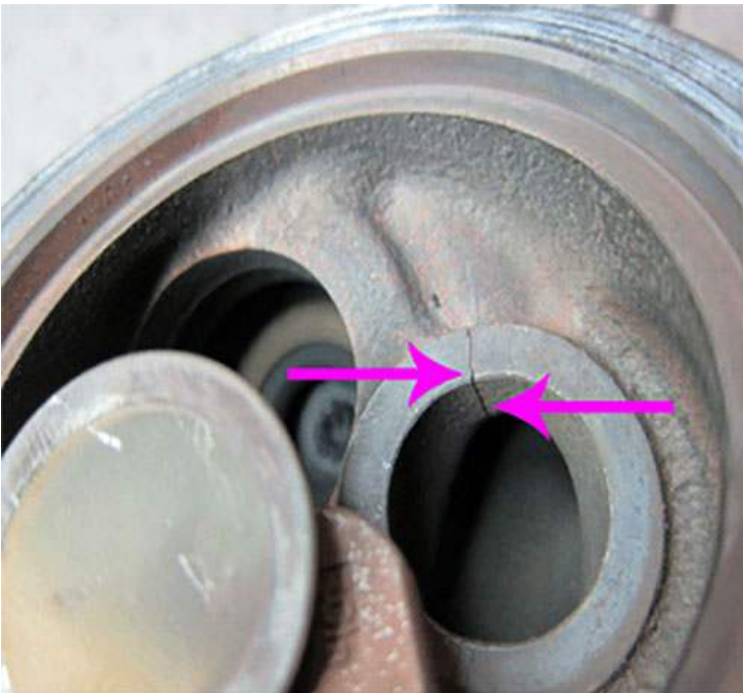
Crack(s) at the wastegate valve port (this is normal and does not affect performance)

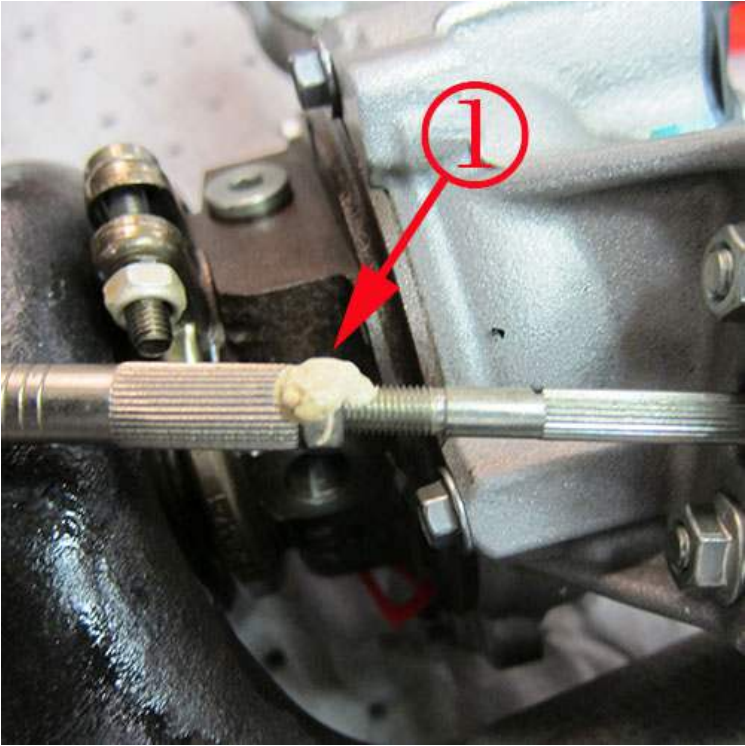
If the tamper paint seal is broken or missing, check the vehicle for any additional sign of modification to the induction, exhaust, or engine calibrations as this may indicate an attempt to adjust the wastegate arm to modify the powertrain operation.

If found, review the powertrain warranty status with your service manager prior to performing repairs

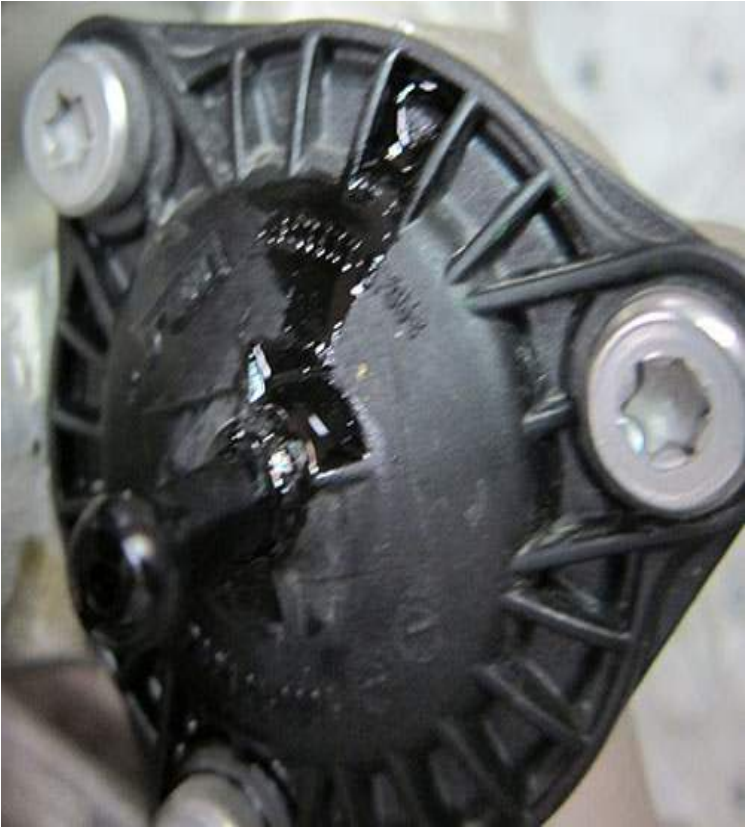
Bypass (recirculation) valve cover port broken or water/oil found inside the valve (clean the components, if necessary replace bypass (recirculation) valve assembly - released for service)

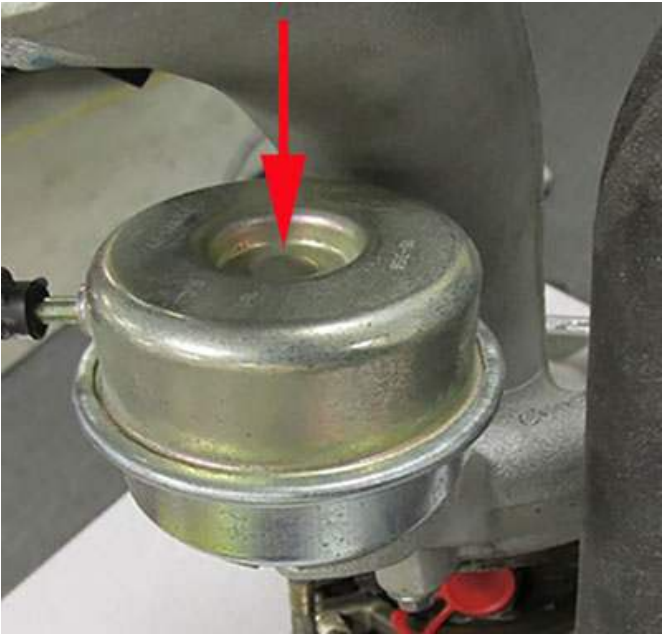
The original equipment wastegate actuator found on 2011 and 2012 model years shown below, has a recessed stop at the head of the actuator.

Original equipment actuator is found on 2011 and 2012 model years.

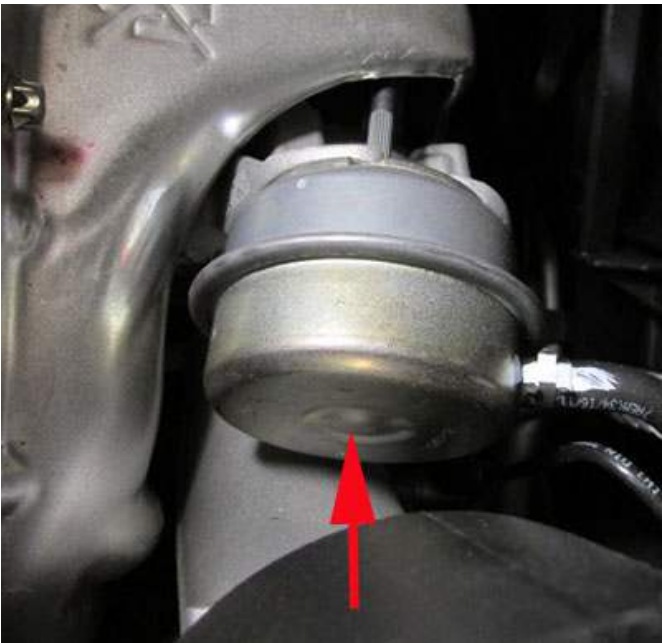
The updated design actuator shown below has a stop that is not recessed and allows 5mm more travel in the closed direction.

With this updated design, it is very unlikely that an insufficient preload issue exists.

Updated design.

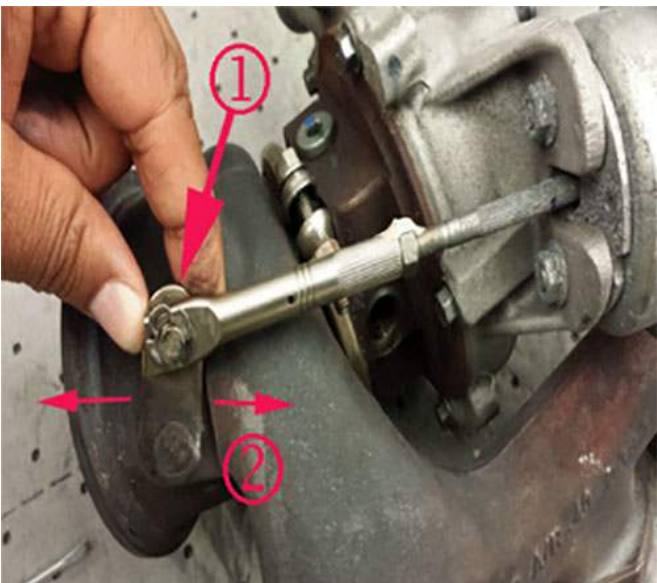
Wastegate Preload Inspection.

If the lever wiggles with little effort while the actuator rod remains static, the pre-load is insufficient and the turbocharger must be replaced.
