GLOBAL SAFETY FIELD INVESTIGATIONS  
DCS5334  
URGENT - DISTRIBUTE IMMEDIATELY

Subject: N192285430 - Service Update  
Engine Control Module Calibration Error

Models: 2020 Chevrolet Silverado HD  
2020 GMC Sierra HD  
Equipped with Diesel Engine, 8 CYL, 6.6 L (RPO L5P)

## N192285430 Engine Control Module Calibration Error

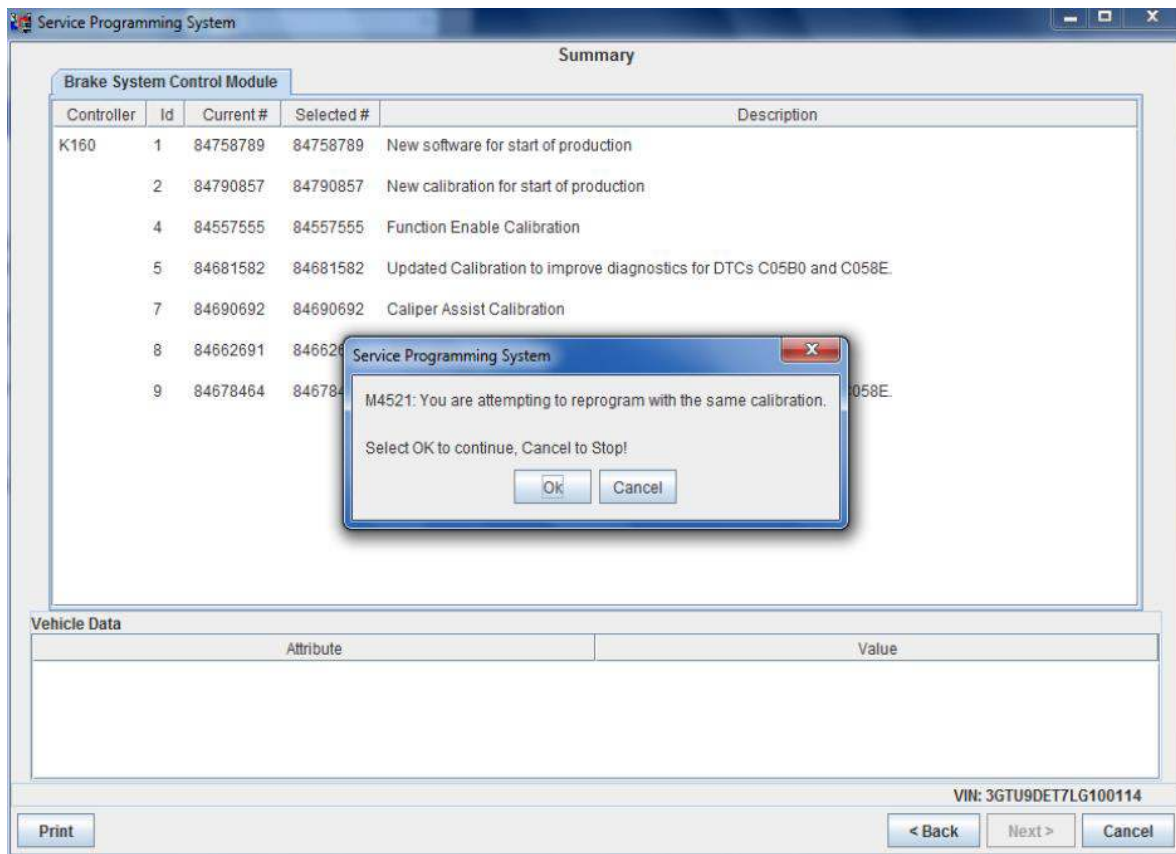
5431207

**Important:** If the Same Calibration/Software Warning is noted on the SPS screen, select OK and follow screen instructions. After a successful programming event, the WCC is located in the Service Programming System dialogue box of the SPS Summary screen. No further action is required. Refer to the Warranty section of the bulletin.

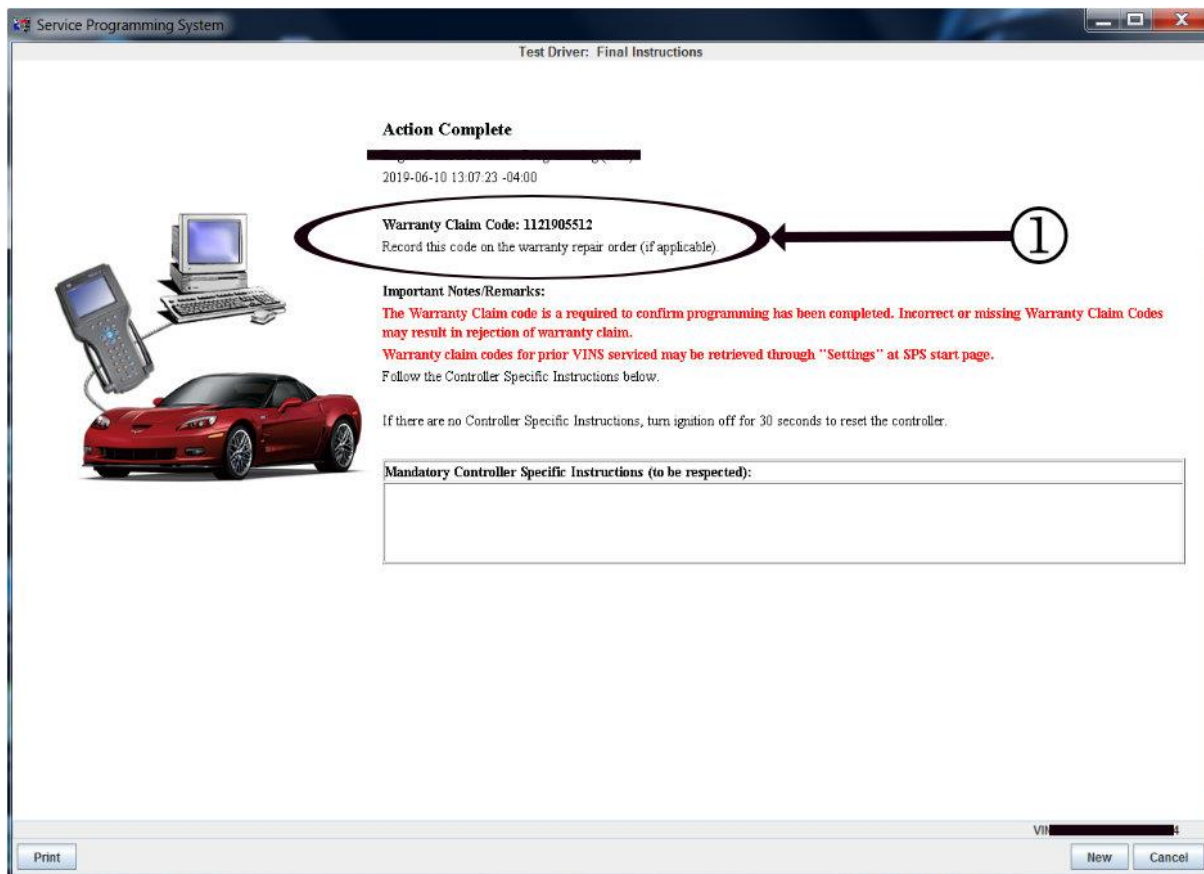
5431209

**Important:** To avoid warranty transaction rejections, you **MUST** record the warranty claim code provided on the SPS Warranty Claim Code (WCC) screen on the job card. Refer to callout 1 above for the location of the WCC on the SPS screen.

- Record SPS Warranty Claim Code on job card for warranty transaction submission.
