# Technical Service Bulletin

## 91 Trunk lid taillight does not work or flickers, DTC B16D5F1/B16DF52/B16D5F6/B16D7F1/B16D7F6 stored in comfort module

91 20 42 2058647/1 March 2, 2020.

| Model(s) | Year | VIN Range | Vehicle-Specific Equipment |
|---|---|---|---|
| Audi e-tron quattro | 2019 | 000001 – 025632 | Not Applicable |

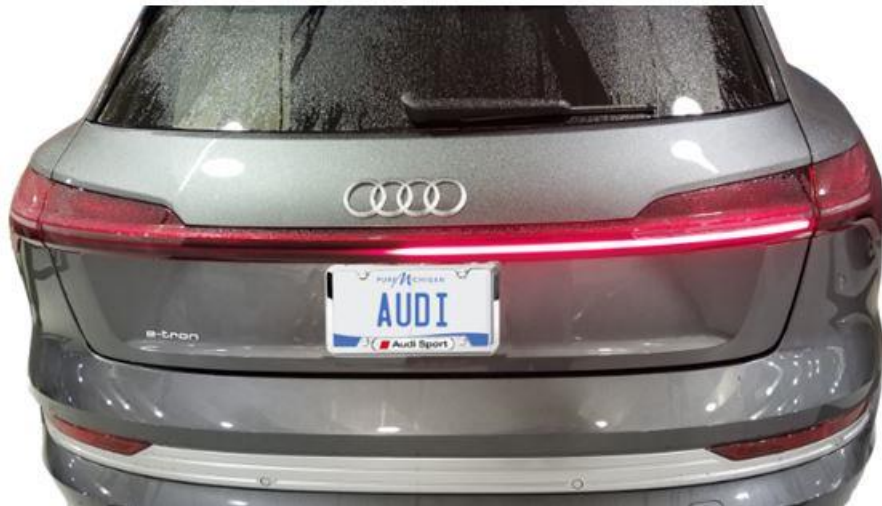
High resistance may form between the printed circuit board and LED contact points within the trunk lid taillight.

This can cause the light to flicker or only be partially lit (Figure 1).

**Figure 1.** Partially lit trunk lid taillight.

1. Attempt to duplicate the customer concern and compare faults to the workshop findings section of this TSB.
2. If the customer concern and/or the faults match, replace the center taillight. Ensure the GFF log is uploaded to GFF paperless.
