# Technical Service Bulletin

## 94 Light malfunction message in instrument cluster, DTC 03280, 01800, B126AF0 or B126AF1 stored in the vehicle module

94 20 20 2017806/13 March 17, 2020. Supersedes Technical Service Bulletin Group 94 number 19-13 dated September 17, 2019 for reasons listed below.

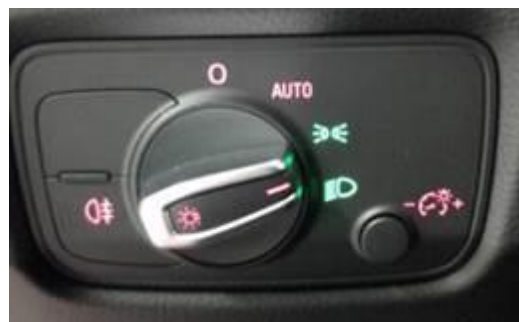
In this example, the intermediate position of the rotary knob (Figure 3) is correctly detected in the MVBs of the 09 module (Figure 4). This is normal and does not indicate a faulty component. In this case, explain the operation to the customer.

**Figure 3.** Switch in an intermediate position (2018 A4).

Determine if the above situation applies to the vehicle, and explain the *Technical Background* to the customer. Replacing parts does not change the behavior.
