# Service Bulletin

Bulletin No.: 19-NA-057

Subject: Malfunction Indicator Lamp (MIL) Illuminated, DTC P0420 Set

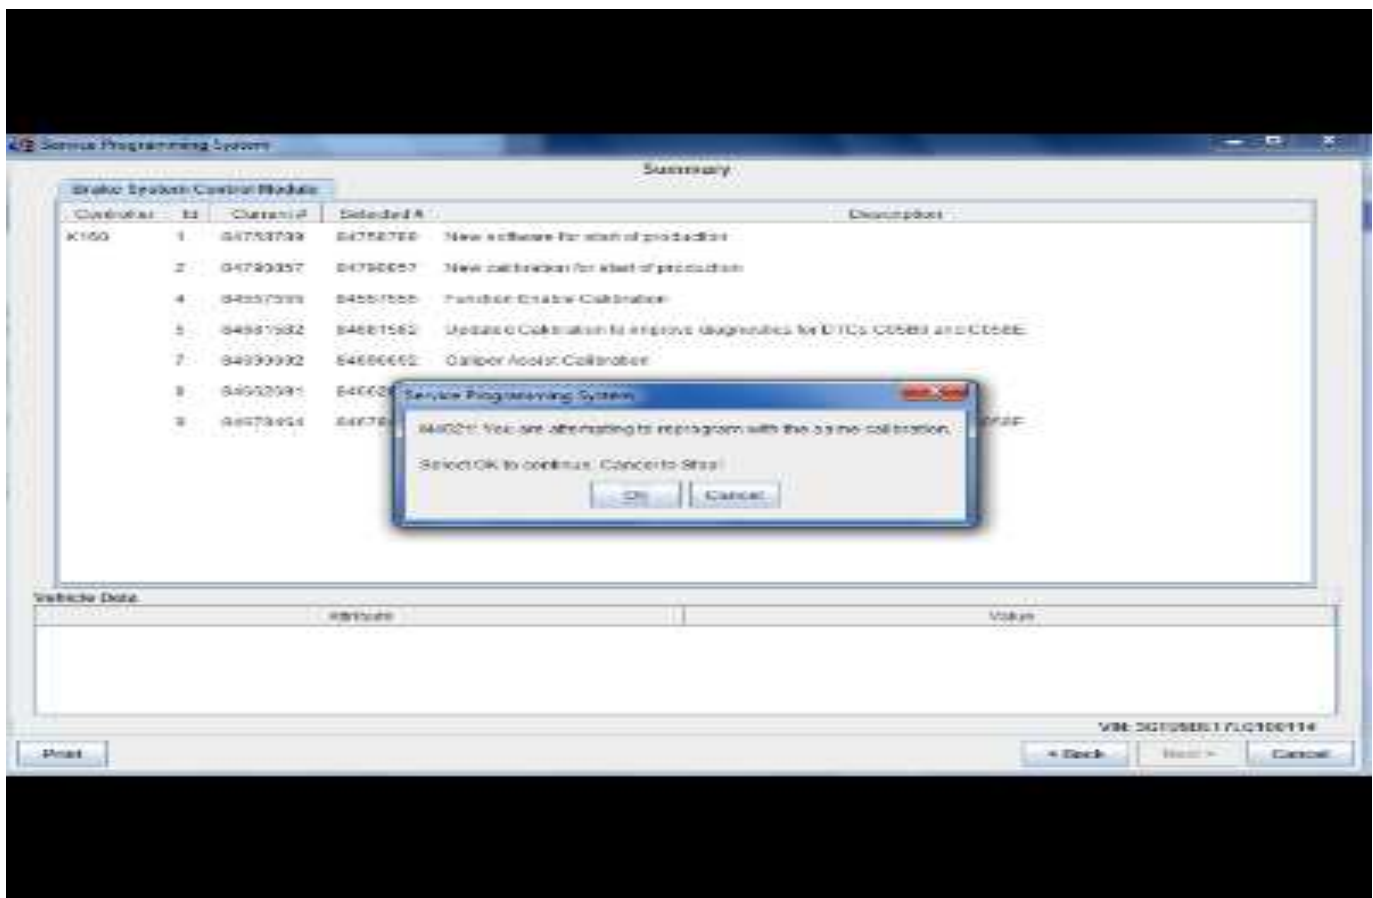
5431207

Important: If the Same Calibration/Software Warning is noted on the SPS screen, select OK and follow screen instructions. After a successful programming event, the WCC is located in the Service Programming System dialogue box of the SPS Summary screen. No further action is required. Refer to the Warranty section of the bulletin.

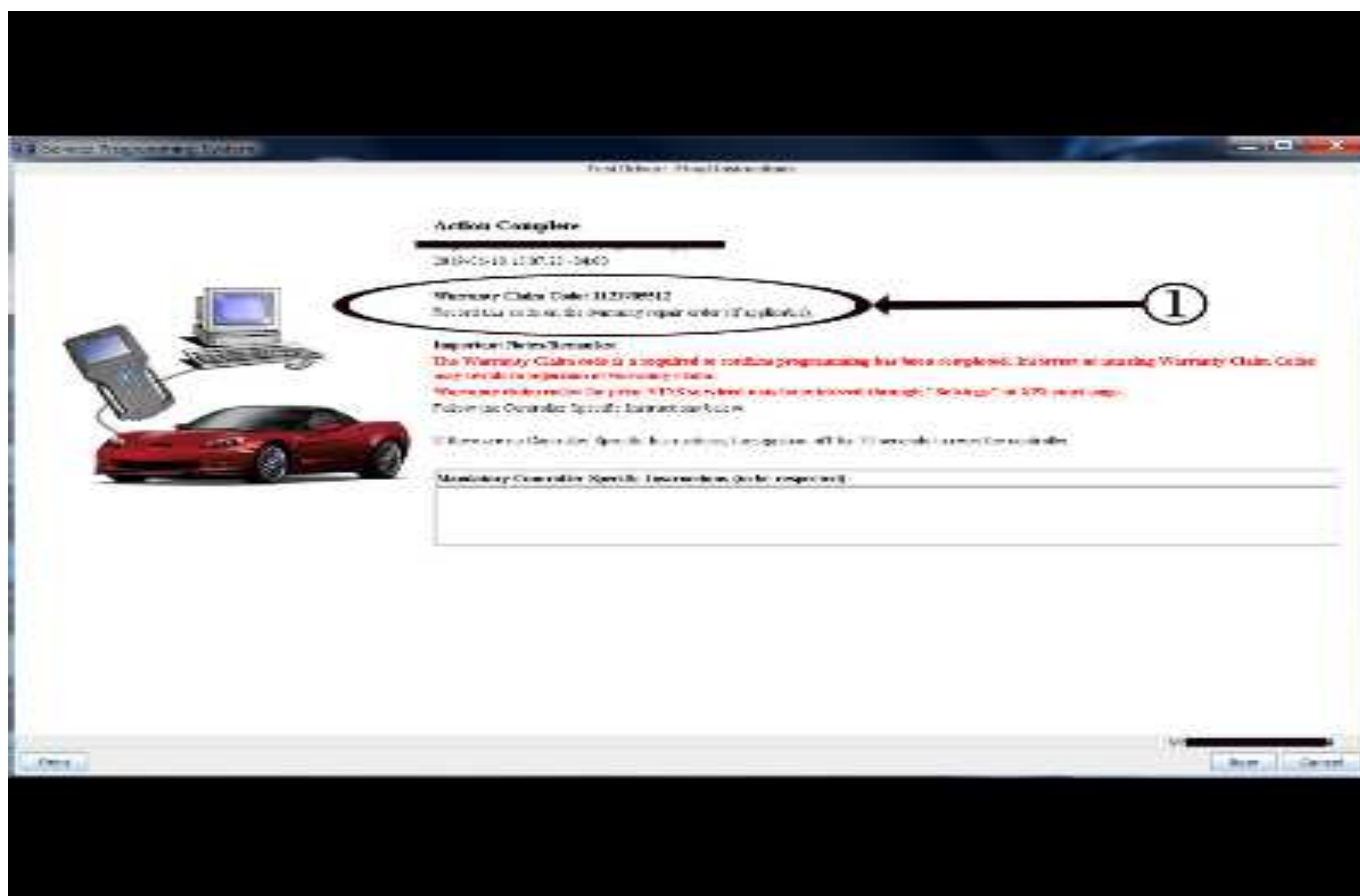
5431209

**Important:** To avoid warranty transaction rejections, you **MUST** record the warranty claim code provided on the SPS Warranty Claim Code (WCC) screen on the job card. Refer to callout 1 above for the location of the WCC on the SPS screen.
