# Service Bulletin

Bulletin No.: 20-NA-003

**Subject:** Service Driver Assist Message Illuminated, Front Seat Lane Departure Warning Actuator Inoperative, DTC B172E Set

| Brand: | Model: | Model Year: | | VIN: | | Engine: | Transmission: |
|---|---|---|---|---|---|---|---|
| Buick | Envision | 2016 | 2019 | | | All | All |

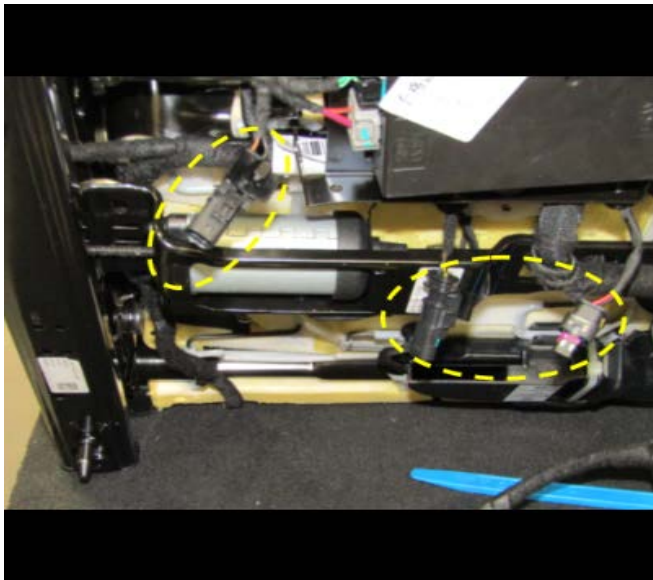
5479756

Note: The harness rework is a swapping of the terminal polarity on the actuator connectors (shown circled above). Ensure to complete the rework BEFORE reassembly of the seat.

2. Rework the actuator harness, following the steps below.
