## SERVICE CAMPAIGN BULLETIN

EC20-006

NTB20-021

### VOLUNTARY SERVICE CAMPAIGN ENGINE CONTROL MODULE

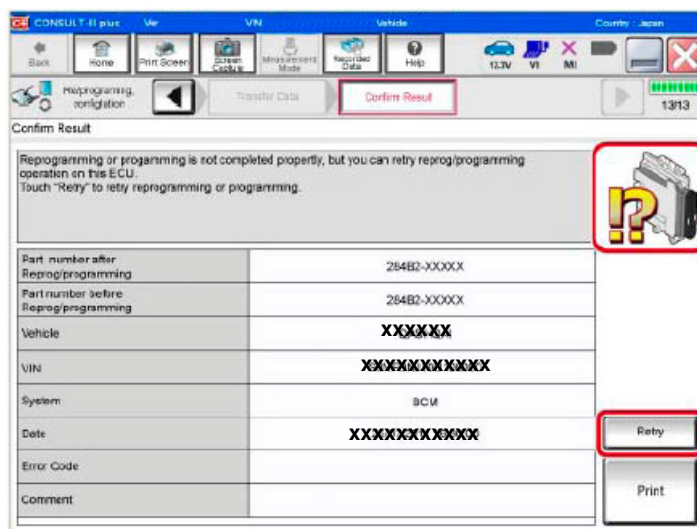
Figure 1

If reprogramming does not complete and the “!” icon displays as shown in Figure 1:

- Check battery voltage (12.0 - 15.5 V).
- Ignition is ON, engine OFF.
- External Bluetooth® devices are OFF.
- All electrical loads are OFF.
- **Select retry and follow the on screen instructions.**
- “Retry” may not go through on first attempt and can be selected more than once.

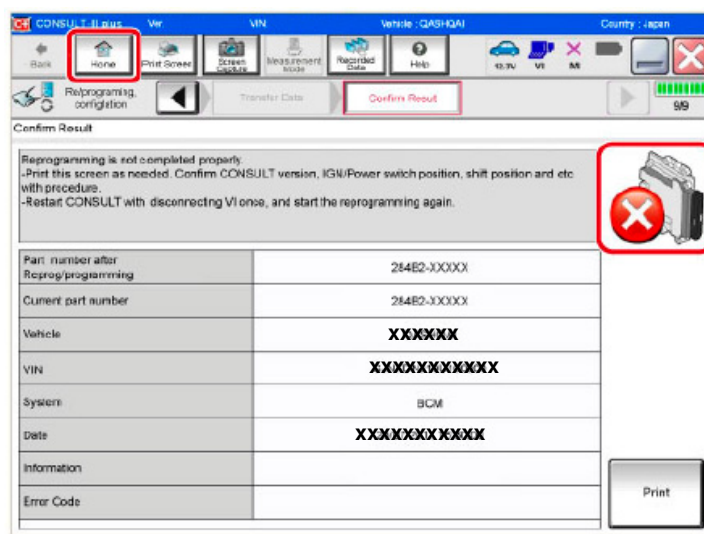
Figure 2

If reprogramming does not complete and the “X” icon displays as shown in Figure 2:

- Check battery voltage (12.0 - 15.5 V).
- CONSULT A/C adapter is plugged in.
- Ignition is ON, engine OFF.
- Transmission is in Park.
- All C-III plus / VI cables are securely connected.
- All C-III plus updates are installed.
- **Select Home, and restart the reprogram procedure from the beginning.**
