EC20-007

ITB20-013

## VOLUNTARY SERVICE CAMPAIGN 2019 Q70 AND 2019 QX80; ENGINE CONTROL MODULE

CAMPAIGN ID #: P0A06  
APPLIED VEHICLES: 2019 Q70 (Y51)  
2019 QX80 (Z62)  
APPLIED ENGINE: VK56VD

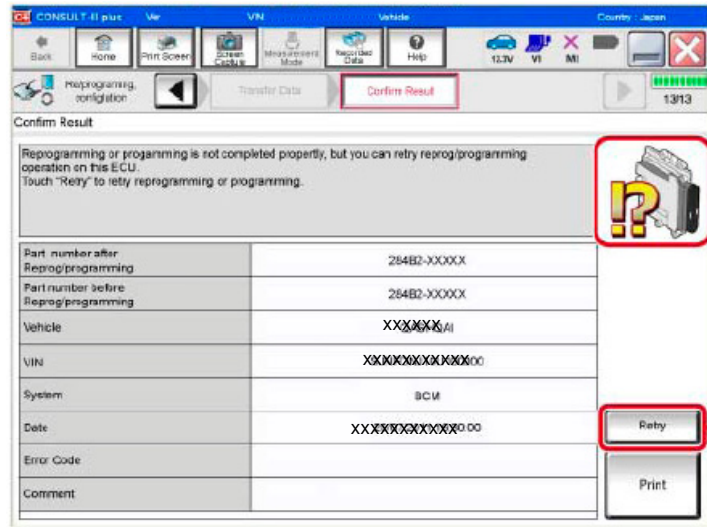
Figure 1

If reprogramming does not complete and the “!” icon displays as shown in Figure 1:

- Check battery voltage (12.0 - 15.5 V).
- Ignition is ON, engine OFF.
- External Bluetooth® devices are OFF.
- All electrical loads are OFF.
- Select retry and follow the on screen instructions.
- “Retry” may not go through on first attempt and can be selected more than once.

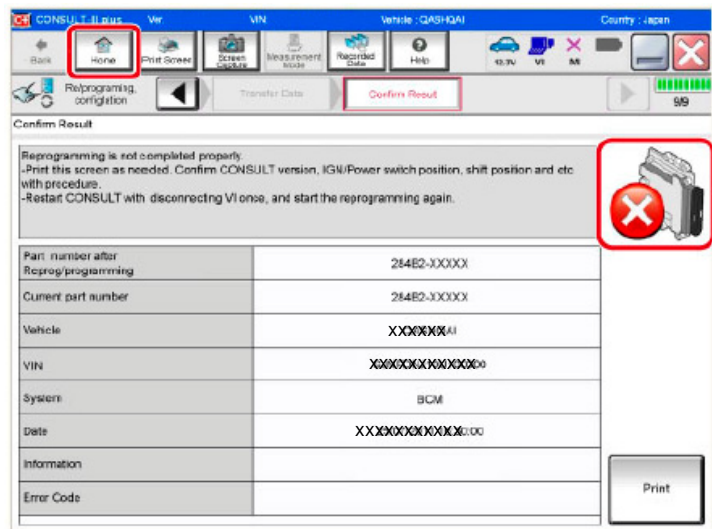
Figure 2

If reprogramming does not complete and the “X” icon displays as shown in Figure 2:

- Check battery voltage (12.0 - 15.5 V).
- CONSULT A/C adapter is plugged in.
- Ignition is ON, engine OFF.
- Transmission is in Park.
- All C-III plus / VI cables are securely connected.
- All C-III plus updates are installed.
- Select Home, and restart the reprogram procedure from the beginning.
