# MIL ON With DTC(s) P1C5F19 and/or P1C5D19 Causing Over-current Condition

| YEAR(S) | MODEL(S) | ADDITIONAL INFORMATION |
|---|---|---|
| 2019 - 2020 | ES300H, UX250H | |

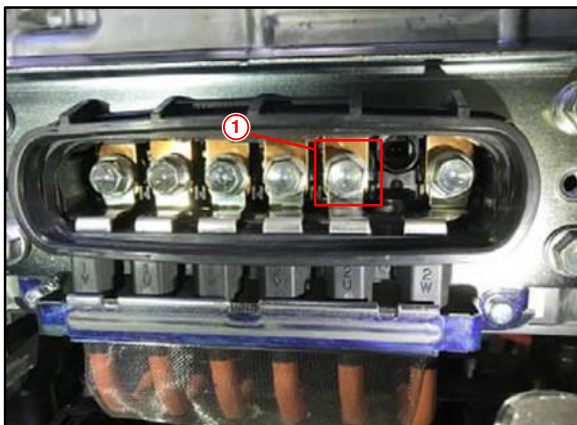
**Figure 1. View of Terminals at the Inverter**

**1** Close-Up View of Terminal (See Figure 2)

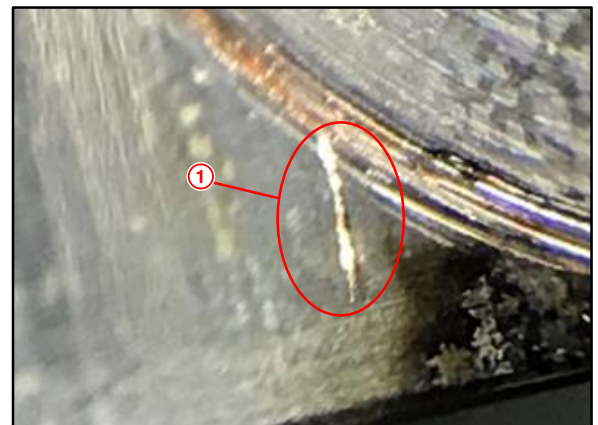
**Figure 2. Close-Up View of Terminal**

Some 2019 – 2020 model year ES 300h UX 250h vehicles may exhibit a MIL ON condition with a “Hybrid System Malfunction” message displayed and one or more of the following DTC(s) that represent an over current between the MG1, MG2, and inverter/PCU:

These conditions typically occur on low vehicle mileage (less than 5,000). After an occurrence, the vehicle will be able to run normally with no drivability issues. Follow the Repair Procedure in this bulletin to address these conditions.

**1** Debris Created From Bolt Tightening

3. Using compressed air, blow out ALL potential debris on the terminals and connections area of the inverter and transaxle. Visually confirm there is no debris present on terminals and connections area.
4. Reinstall the MG cable with NEW bolts into the transaxle assembly. Inverter bolts can be reused. Refer to TIS, applicable model and model year Repair Manual:
  - 2019 – 2020 ES 300h:  
*Drivetrain – Hybrid Transmission/Transaxle* – “[P710 \(Hybrid Transmission / Transaxle\): Motor Cable: Installation](#)”
  - 2019 – 2020 UX 250h:  
*Drivetrain – Hybrid Transmission/Transaxle* – “[P711 \(Hybrid Transmission / Transaxle\): Motor Cable: Installation](#)”

Ensure correct fastening tools and torque are used when installing the MG cable. Over tightening can create additional debris.
