# MIL ON With DTC(s) P1C5F19 and/or P1C5D19 Causing Over-current Condition

Some 2019 – 2020 model year Avalon Hybrid, Camry Hybrid, and RAV4 Hybrid vehicles may exhibit a MIL ON condition with a “Hybrid System Malfunction” message displayed and one or more of the following DTC(s) that represent an over current between the MG1, MG2, and inverter/PCU:

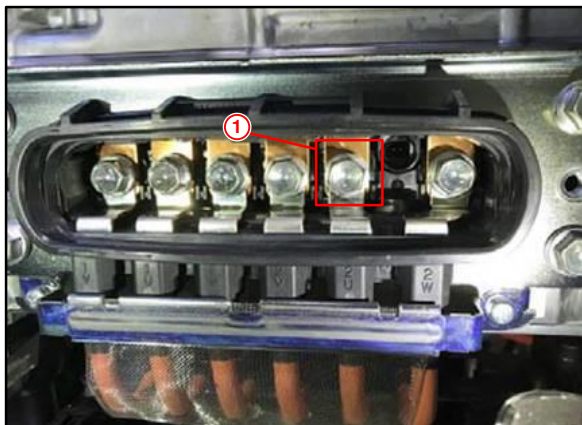
**Figure 1. View of Terminals at the Inverter**

**1** Close-Up View of Terminal (See Figure 2)

3. Using compressed air, blow out ALL potential debris on the terminals and connections area of the inverter and transaxle. Visually confirm there is no debris present on terminals and connections area.
4. Reinstall the MG cable with NEW bolts into the transaxle assembly. Inverter bolts can be reused. Refer to TIS, applicable model and model year Repair Manual:
  - [2019](#) / [2020](#) Avalon HV:  
*Drivetrain – Hybrid Transmission/Transaxle – “P710 (Hybrid Transmission / Transaxle): Motor Cable: Installation”*
  - [2019](#) / [2020](#) Camry HV:  
*Drivetrain – Hybrid Transmission/Transaxle – “P710 (Hybrid Transmission / Transaxle): Motor Cable: Installation”*
  - [2019](#) / [2020](#) RAV4 HV:  
*Drivetrain – Hybrid Transmission/Transaxle – “P710 (Hybrid Transmission / Transaxle): Motor Cable: Installation”*

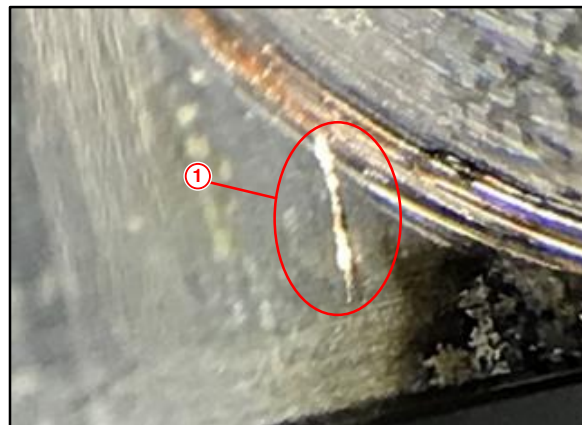
**Figure 2. Close-Up View of Terminal**

**1** Debris Created From Bolt Tightening

Ensure correct fastening tools and torque are used when installing the MG cable. Over tightening can create debris.
