# Service Bulletin

Bulletin No.: 20-NA-068

Date: March, 2020

**Subject:** Service Engine Soon Message on Driver Information Center (DIC) with the following DTCs set: P00FF, B2B05, B2B06

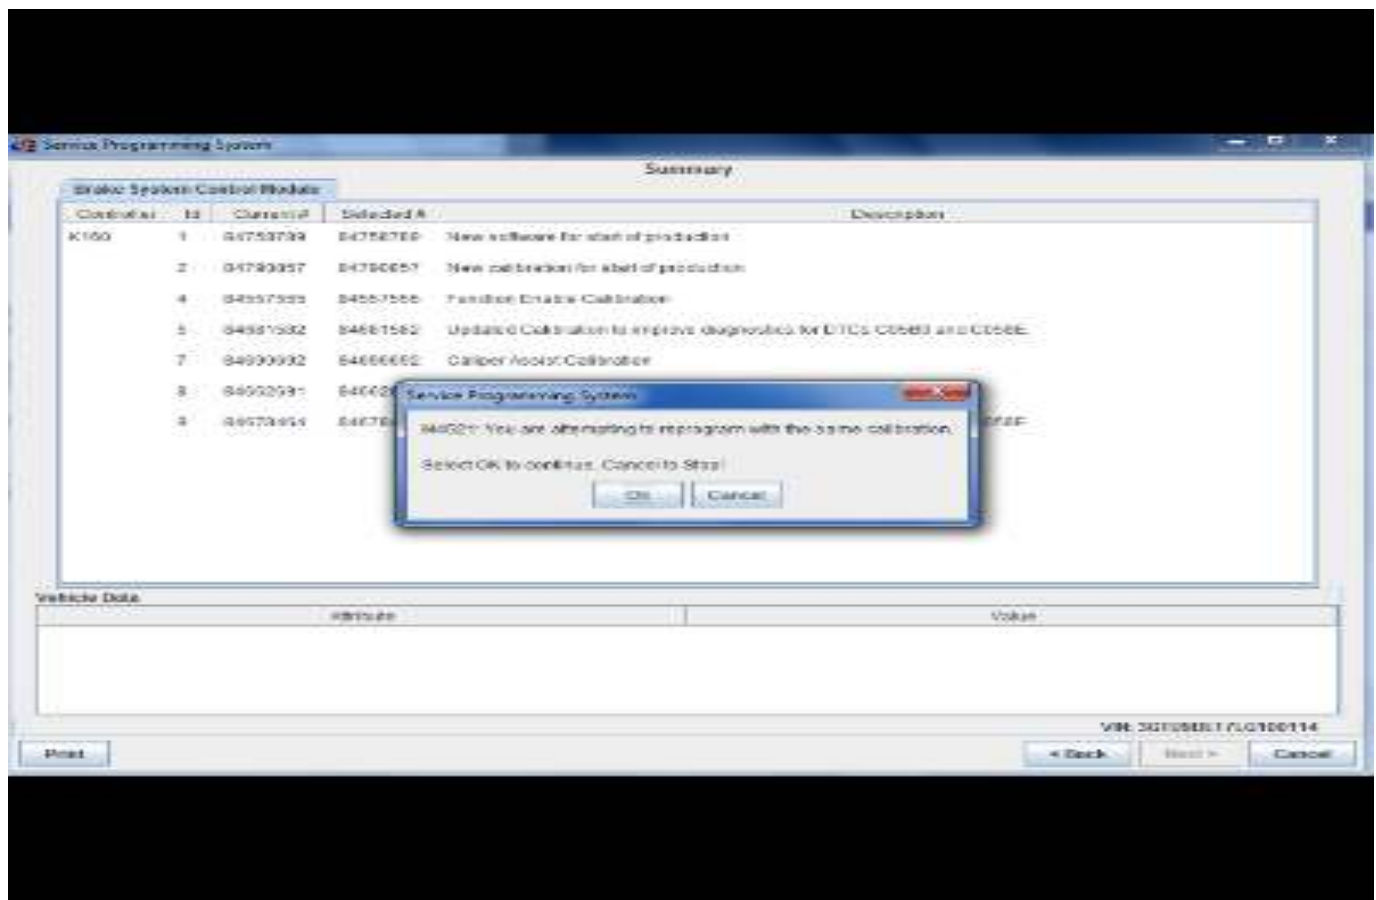
5431207

Important: If the Same Calibration/Software Warning is noted on the SPS screen, select OK and follow screen instructions. After a successful programming event, the WCC is located in the Service Programming

System dialogue box of the SPS Summary screen. No further action is required. Refer to the Warranty Information section of this bulletin.
