# Technical Service Bulletin

**20 MIL on or difficulty refueling, DTC P045100, P044100, P202500, and/or P045300 are stored in the ECM**

20 20 26 2050276/6 April 23, 2020. Supersedes Technical Service Bulletin Group 20 number 20-25 dated February 12, 2020 for reasons listed below.

| Model(s) | Year | VIN Range | Vehicle-Specific Equipment |
|---|---|---|---|
| A6, A7 | 2016 - 2018 | All | 3.0T and 2.0T |

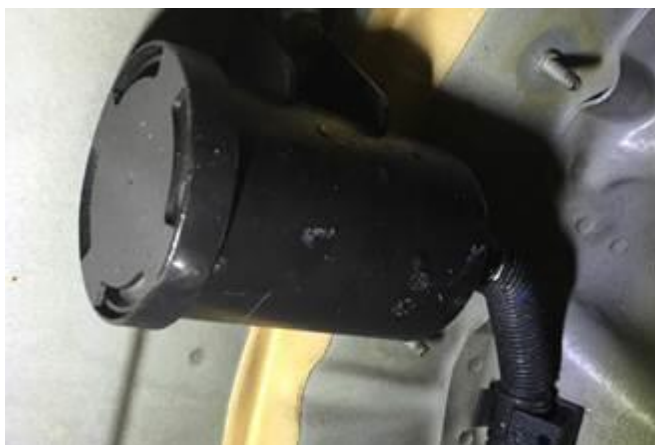
**Figure 2.** Ventilation tube of the EVAP canister.

1. If the updated wheel liner has not yet been installed. Then install the updated wheel liner, which has closed slots around the NVLD filter.
  - Remove the EVAP canister, ventilation tube, and NVLD pressure switch.
  - Remove all components mounted on the EVAP canister.
2. Weigh the EVAP canister:
  - If it weighs more than 2650 grams, replace the EVAP canister + attached filter, ventilation tube (Figure 2), and NVLD pressure switch (J909).
  - If it weighs less than 2650 grams, replace the ventilation tube, and the J909.

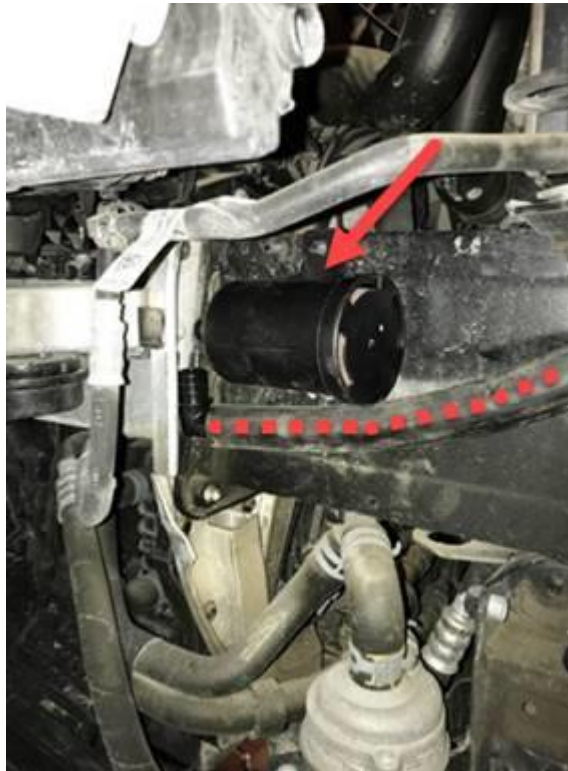
**Figure 3.** Installing the new NVLD filter.

1. Replace the EVAP canister only if weight is greater than 2650 grams.
  - Install a new J909.
  - Install the NVLD filter (new part number, Version 2) in the engine compartment on the left frame rail just in front of the ABS module, secure with M6 nut. (Figure 3).

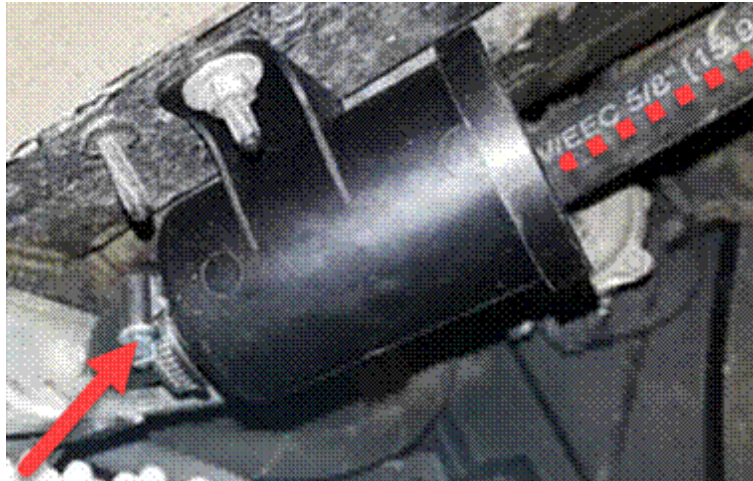
**Figure 4.** Connecting the NLVD filter.

2. Connect the filter to the 5/8" ID rubber hose via 1x plastic elbow and 1x rubber elbow (Figure 4).

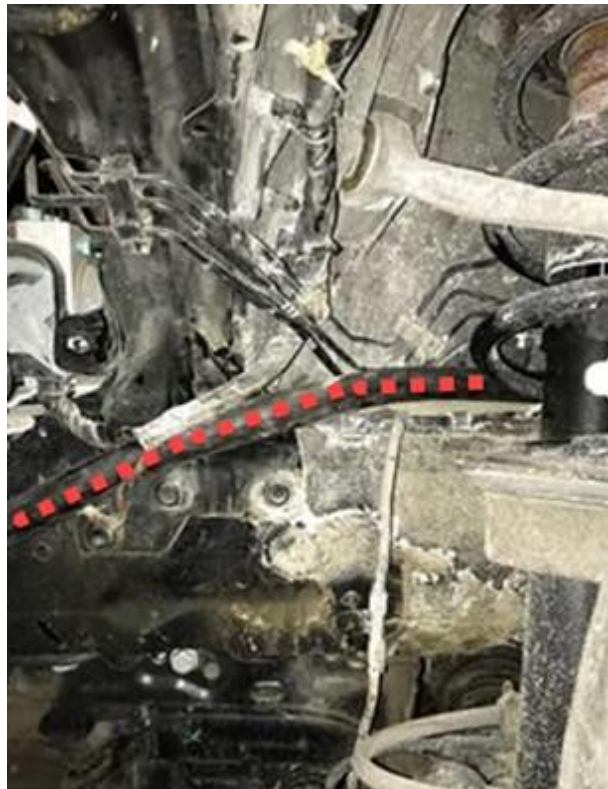
**Figure 5.** Route the 5/8" ID rubber hose from new filter position to the J909.

- Route the 5/8" ID rubber hose behind the strut and brake lines from new filter position to the J909, along the orange battery cable (Figure 5 and 6). Then secure with zip ties.
- 3.

5/8" ID rubber hose needs to be routed in a way that there are no sharp bends to prevent kinking.

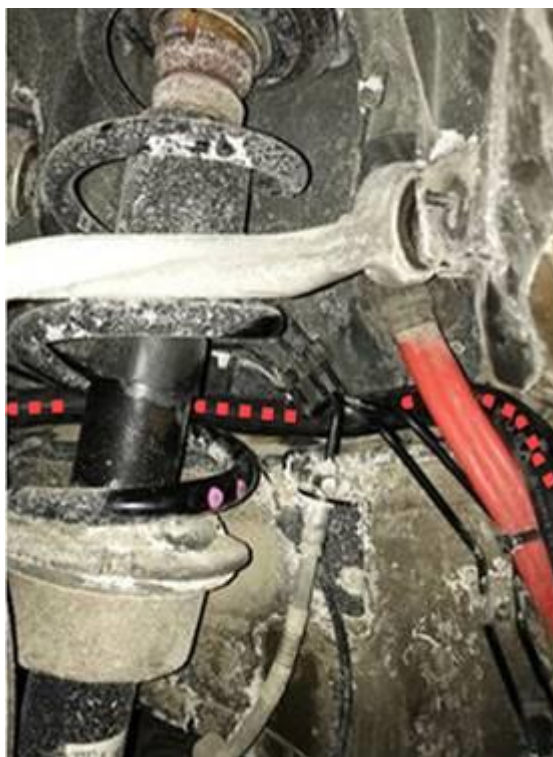
*Figure 6. Routing the rubber hose.*

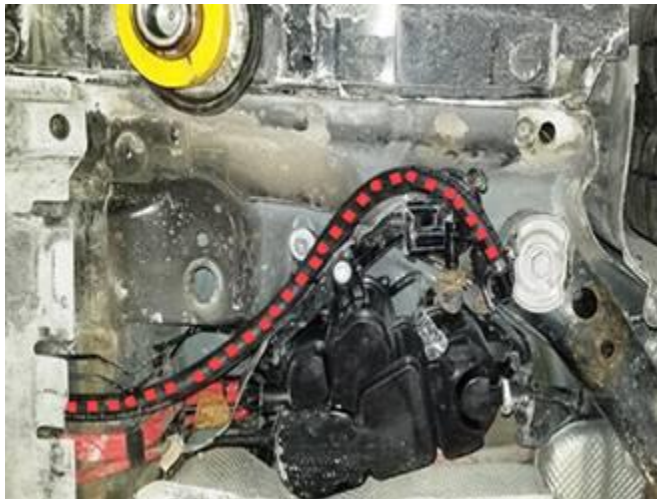
*Figure 8. Connecting to the J909.*

5. Before connecting 5/8" ID rubber hose to 90 degree connector, cut to length, as needed. Connection details to the J909 are shown in Figure 8 and 9.

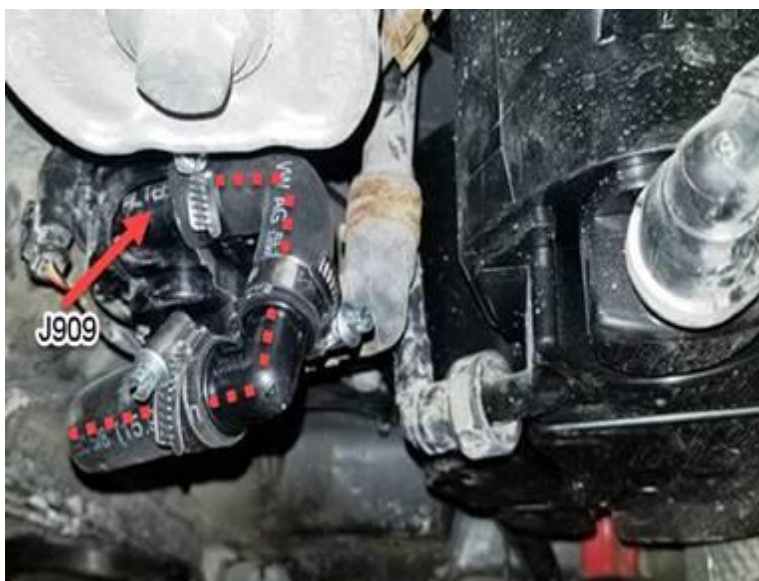
**Figure 9.** Closer look at the connections.

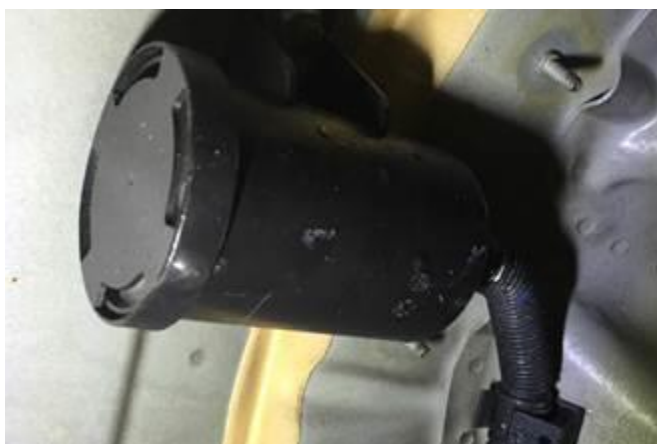
**Figure 10.** Remove original NVLD filter.

6. Remove original NVLD filter assembly. (Figure 10).
