# Technical Service Bulletin

## 91 SOS warning displayed in instrument cluster, DTCs B105313 and B153313 stored in the data bus diagnostic interface

91 20 60 2054812/3 April 22, 2020. Supersedes Technical Service Bulletin Group 91 number 19-58 dated May 13, 2019 for reasons listed below.

| Model(s) | Year | VIN Range | Vehicle-Specific Equipment |
|---|---|---|---|
| A4, A5 | 2018 - 2019 | All | With connected gateway and eCall |

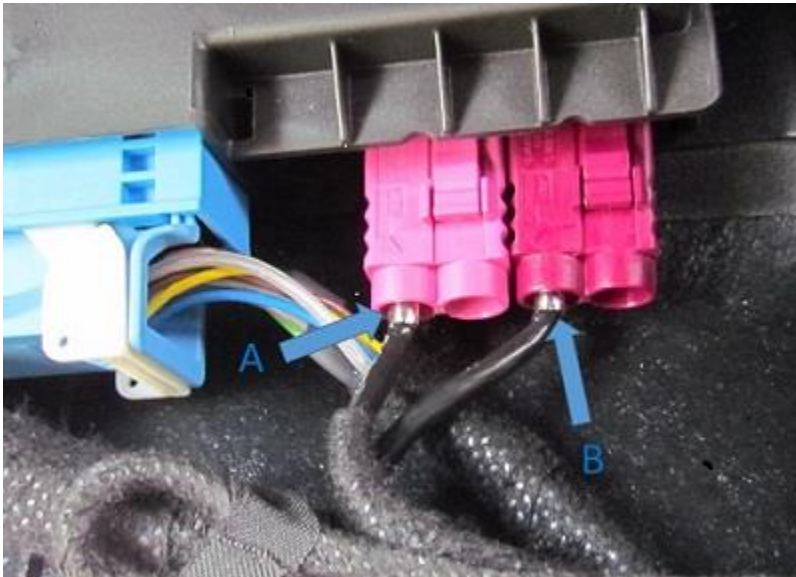
Poor contact at one of the coaxial wiring's FAKRA connections between data bus on board diagnostic interface, J533 (address word 0019) and one of the external antennas for emergency call services.

| DTC Reference Table | | | |
|---|---|---|---|
| DTC | Measured Value<br>Diagnostic Address 0019 | Cable Position<br>(Figure 2) | Vehicle<br>PR-Codes |
| B105313<br>GSM antenna Open circuit | Antenna for telephone<br>status<br>0x24E2 | A | IW3<br>IW5 + 4GR<br>IW5 + 4GY |
| B153313<br>GSM antenna 2 Open circuit | Status of antenna 2 for<br>phone<br>0x1836 | B | IW3<br>IW5 |

**Figure 2.** GSM antenna location reference at the data bus on board diagnostic interface, J533 (address word 0019).

1. If DTC B105313 or B153313 are found in the data bus on board diagnostic interface, J533 (address word 0019), then replace the coaxial wire from the applicable emergency call module antenna to the data bus on board diagnostic interface, J533 (address word 0019).
2. Utilize the VAS 6720 to build a single coaxial wire from the emergency call module to the data bus on board diagnostic interface, J533 (address word 0019).
  - **Do not** split the new wire at the TIM connection between T2dkx and T2dk.
  - Route the new wire along with the existing harness.
  - Ensure that there are no sharp bends.
  - Ensure there is no tension on the new contacts.
  - The cable should be 8.7ft (2.65m) in length.
  - Transfer the plastic connectors onto new cable.
