Preliminary Information

PIP5724 SES Lamp With Camshaft or Oil Pump System Related DTCs

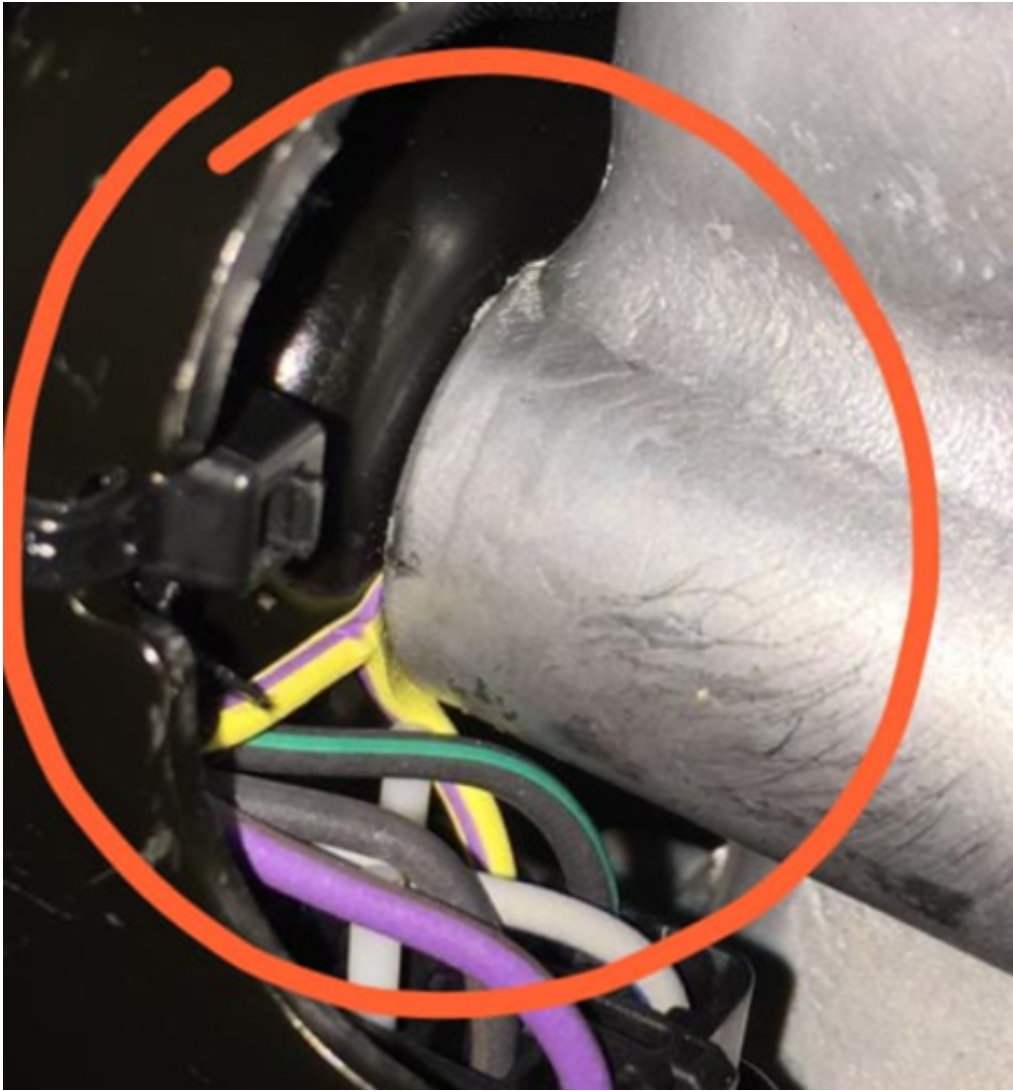
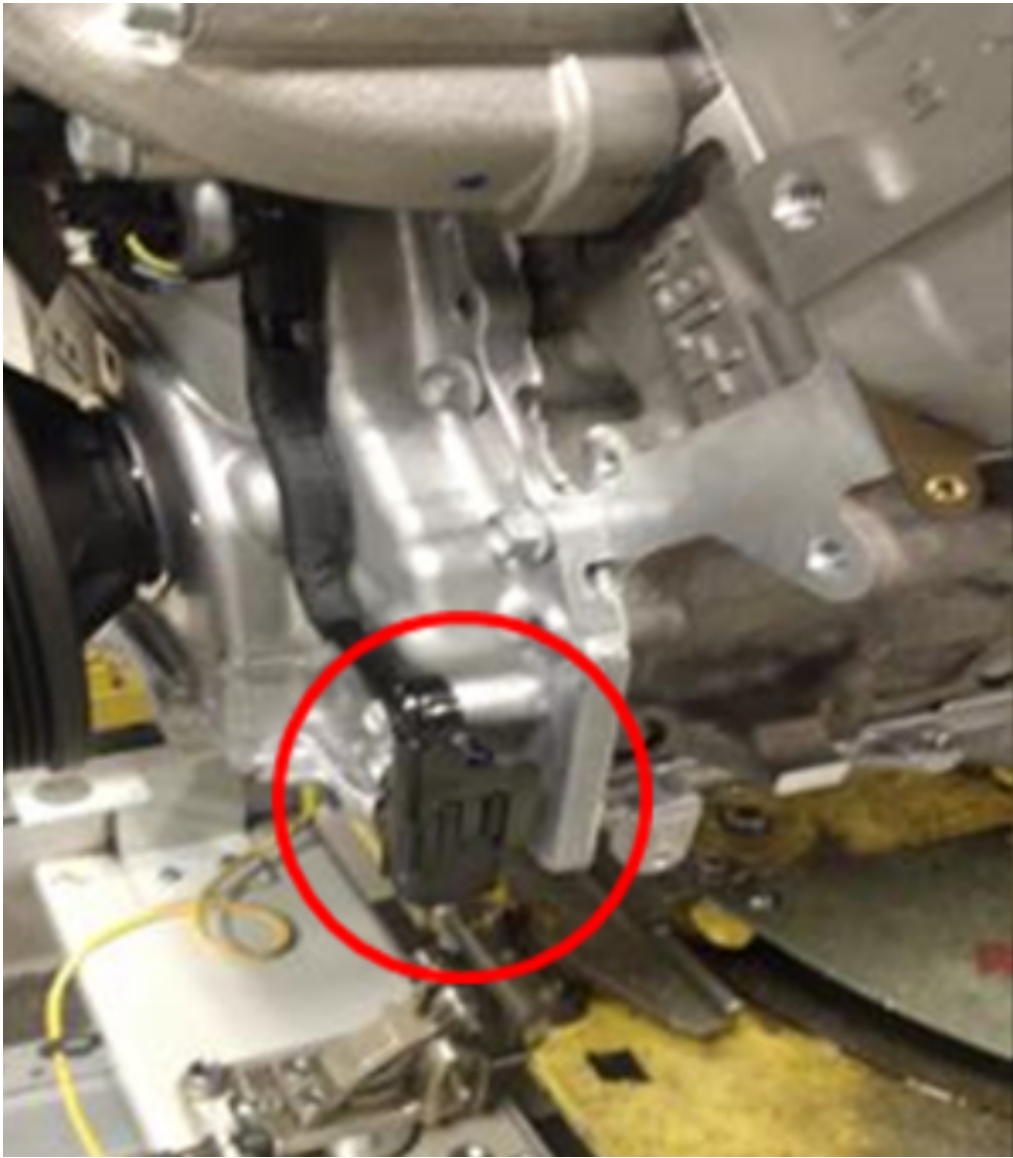
| Cause | Possible wiring jumper harness pinched between the X154 connector bracket and the front engine cover on lower left side of the engine. |

Inspect for the wiring harness being pinched under the bracket on the location below.
