## STAR ONLINE PUBLICATION

**Case Number:** S2018000003

**Symptom/Vehicle Issue:** Customer complaint may include MIL/Check Engine lamp on. Upon further inspection, fault code P219A - Bank 1 Air-Fuel Ratio Imbalance may be found in the powertrain control module (PCM) as pending, active, or stored. Other fault codes P1066, P1068, P106A, or P106C (Solenoid Valve Switch Off Time Out of Range) may also be stored. Customer may also complain about loss of power or engine running rough while P219A is active.

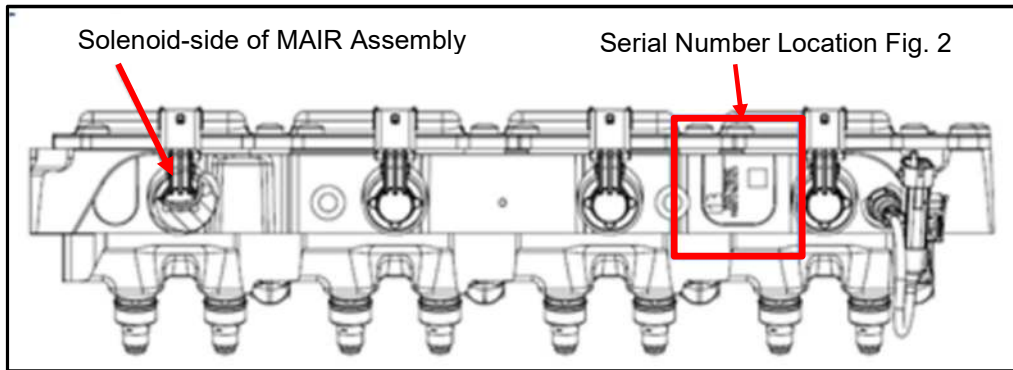
**Fig. 1**

1. Remove the valve cover (cylinder head cover) per published service instructions found in Service Library.
2. Once the MAIR is exposed, locate the serial number etched into the side of the MAIR. See Figures 1 and 2 below for location.

3. If the published diagnostic routine for the fault code listed above does not clearly lead to an engine hardware issue, and the MAIR on the engine was produced before the 10/04/19 clean point, the MAIR unit is suspect and should be replaced.
