## STAR ONLINE PUBLICATION

**Case Number:** S2025000004

**Symptom/Vehicle Issue:** Customer complains of the MIL lamp on. Technician observes DTC P0456 EVAP System Small Leak or P0455 EVAP System Large Leak detected set in PCM.

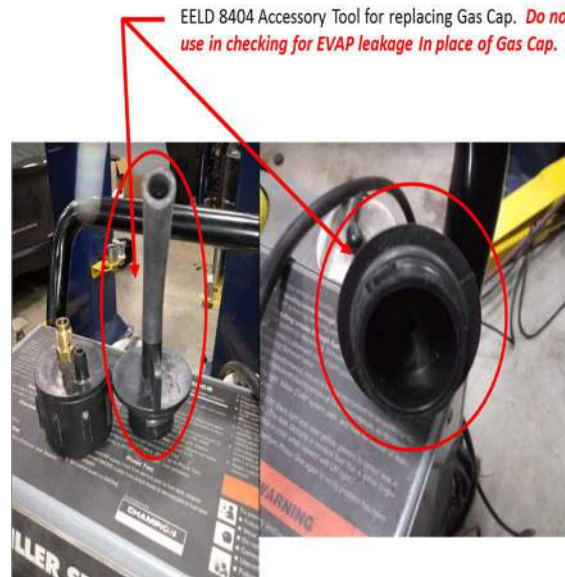
Fig. 1

**Discussion:** When performing the analysis for P0456 and P0455, need to run the wiTECH SLVT. After a confirmation of leakage is detected during the wiTECH SLVT, perform the EVAP Small Leak Verification test using the EELD 8404C smoke/air machine. When performing the wiTECH SLVT or using the EELD smoke/air machine do not remove the original gas cap for determining if an EVAP leakage is occurring. Using the EELD 8404 Accessory Tool shown in figure 1 in place of the gas cap could mask the EVAP leakage due to size of o-ring on the Accessory Tool.

Follow the Service Diagnostics for P0456 and P0455 to properly analyze the leak. For determining if the leakage is occurring in the gas cap area follow the directions in the *FUEL TANK SIDE EVAPORATIVE EMISSION LEAK DETECTION* section by setting the smoke switch on and connecting to the canister tube.

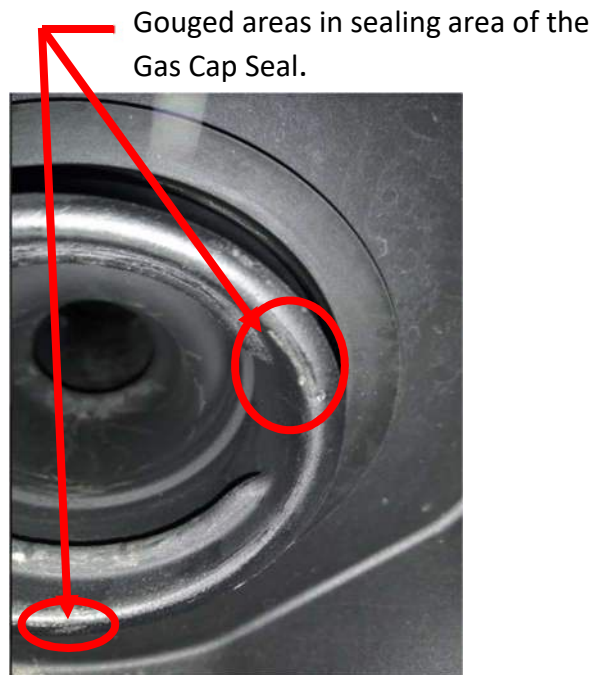
Fig. 2

By using the EELD 8404 Accessory Tool shown in figure 1, the leakage was not detected from the Fuel Filler Tube with a gouge in the sealing area of the Gas Cap, as shown in Figure 2.

If leakage is detected in the gas cap – fuel filler tube area, check for proper tightness of the gas cap. If the gas cap was properly tightened, then remove the gas cap and check for a damaged o-ring or misplaced o-ring. Also, check for gouging or paint chips in the sealing area of the fuel filler tube that could lead to EVAP leakage.
