## SERVICE BULLETIN

**APPLICABILITY:** 2020MY Legacy and Outback

**NUMBER:** 07-176-20

**SUBJECT:** DTCs B118B, B11E5, B11E6 in Driver Monitoring System (DMS)

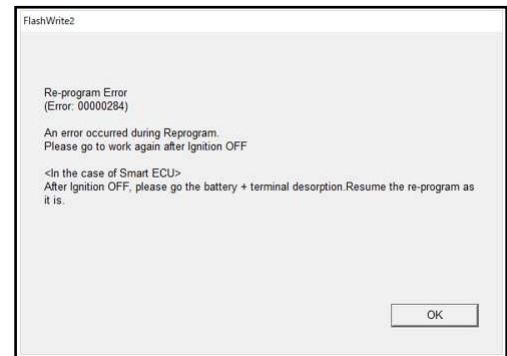
**IMPORTANT:** This DMS requires installation of 2 reprogramming files as shown above. Each file will take about 15 minutes to install. BOTH update files MUST be installed. If this update has been performed previously, a “Latest version already installed” message will be displayed when beginning installation of the first file. Due to the system structure, the FlashWrite reprogramming procedure must be performed twice (once for each file) to complete the update.

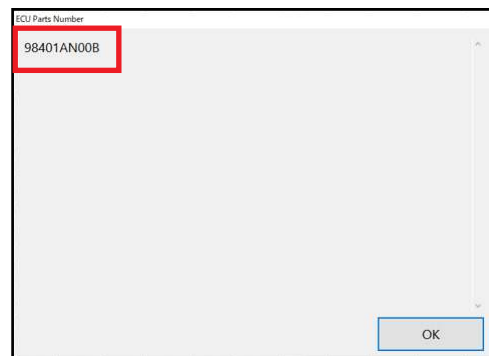
**Step10)** Using the SSM4, confirm the DMS Part Number to confirm the update was successful. Go to: Diagnosis > Confirm VIN > Each System > Driver Monitor (scroll down) > Work Support > ECU Parts Number.

When the update has been completed successfully, the ECU p.n. displayed will be **98401AA00B**. Select OK to complete the procedure.
