# Service Alert

**ENGINE NO START / NO CRANK WITH DTC P0615:12 AND/OR  
B112A:12 STORED**

**Service Alert No.:** SA-051/20

2017-2020 CX-5

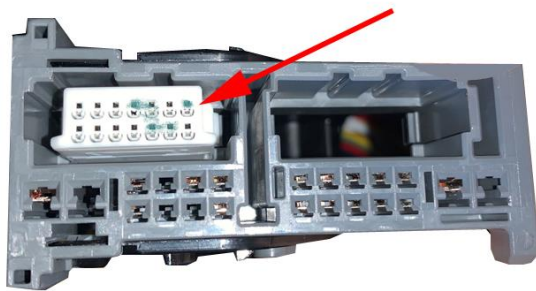
This may be caused by water contamination/corrosion at electrical connector C-04 due to:

- Windshield tint installation:
  - Windshield tint installed to block UV light. The water used during the installation of the tint may run down behind the dashboard. Carefully inspect the windshield to see if window tint has been installed or not. Some window tint film appears clear and is for UV light only.
- Windshield repair/replacement:
  - Poor windshield sealing during installation can cause an internal water leak. Water may run down behind the dashboard.

1. Verify customer concern.
2. Inspect electrical connector C-04 for water contamination/corrosion. Is water corrosion present?
  - Yes - Repair or replace connector C-04.
  - No - This service information does not apply. Go to MGSS:
    - DTC P0615:12 [START STOP UNIT]
    - DTC B112A:12 [START STOP UNIT]
3. Verify repair.
