| <b>HYUNDAI</b><br><b>Technical Service Bulletin</b> | <b>GROUP</b><br><b>AUTOMATIC TRANSMISSION</b> | <b>NUMBER</b><br><b>20-AT-017H</b> |
| <b>SUBJECT:</b> AUTOMATIC TRANSMISSION DTC P0880/P088000 | | |

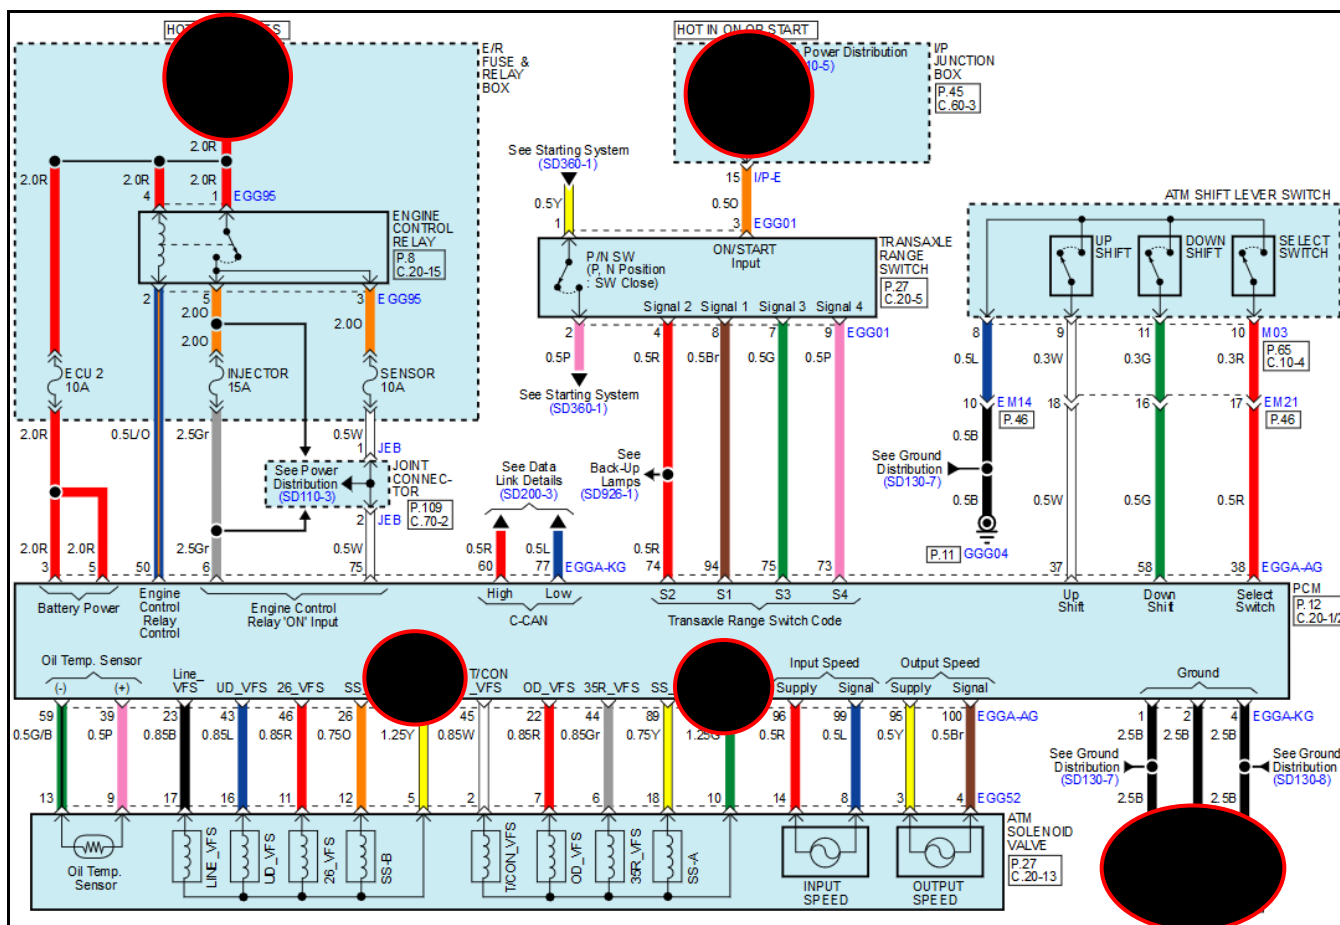
**ETM INFORMATION:** Example only – refer to the related shop manual

**P0880/P088000** is set when solenoid power voltage is lower than 7v or higher than 22v.

**Possible Causes:** Poor connection/circuit fault or faulty PCM.
