| <b>HYUNDAI</b><br><b>Technical Service Bulletin</b> | GROUP<br><b>AUTOMATIC TRANSMISSION</b> | NUMBER<br><b>20-AT-018H</b> |
| <b>SUBJECT:</b> AUTOMATIC TRANSMISSION DTC P0880/P088000 | | |

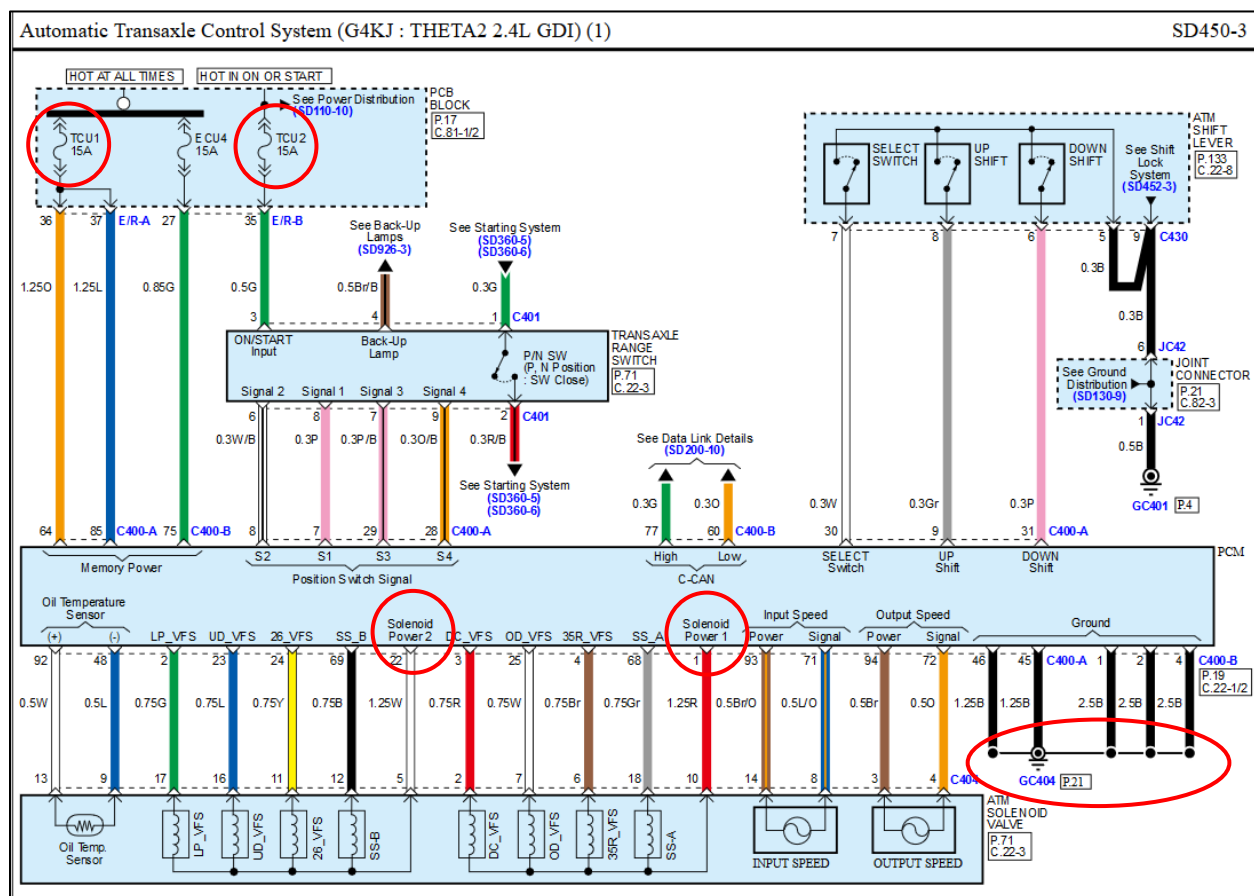
**ETM INFORMATION:** Example only - refer to the related shop manual:

**P0880/P088000** are set when solenoid power voltage is lower than 7v or higher than 22v.

**Possible Causes:** Poor connection/circuit fault or faulty TCU.

2. Refer to the appropriate shop manual, **Schematic Diagrams, Transaxle/Transmission, Automatic Transaxle Control System** and **Schematic Diagrams**.  
Check the TCU1 and TCU2 fuses in the E/R junction box (Refer to ETM Information, Page 2). Confirm the fuse fits tightly and does not have an open circuit.

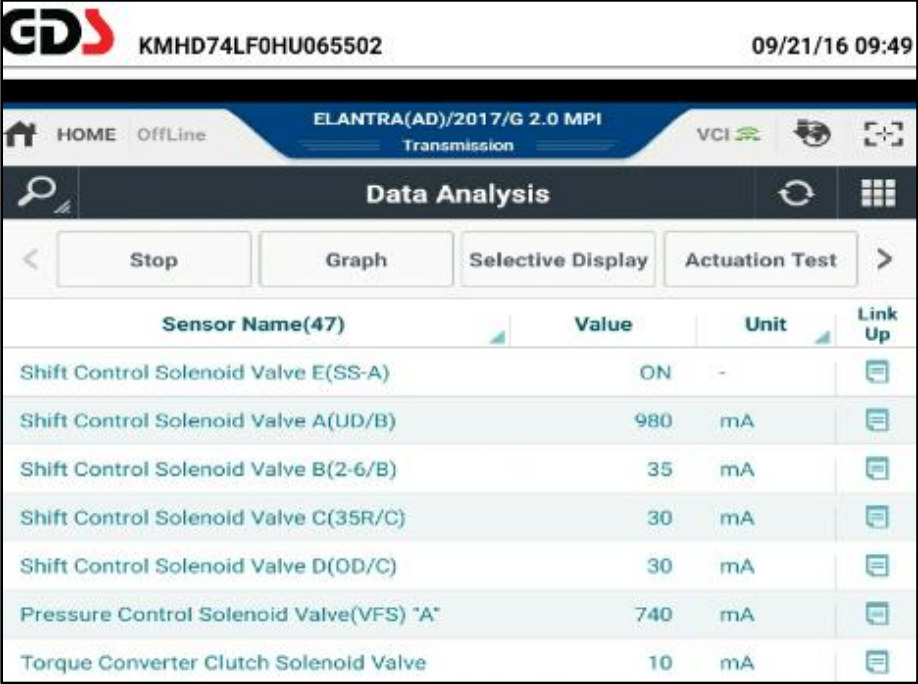
- Continuous and changing output while driving, the solenoids are operating correctly and the wiring **currently** has no open/short circuits. Go to Step 5.

- No continuous and changing output, go to Step 4.
