# Preliminary Information

## PIP5202C (EREV) Diagnostic Tips for Intermittent MIL With DTC P0AB9

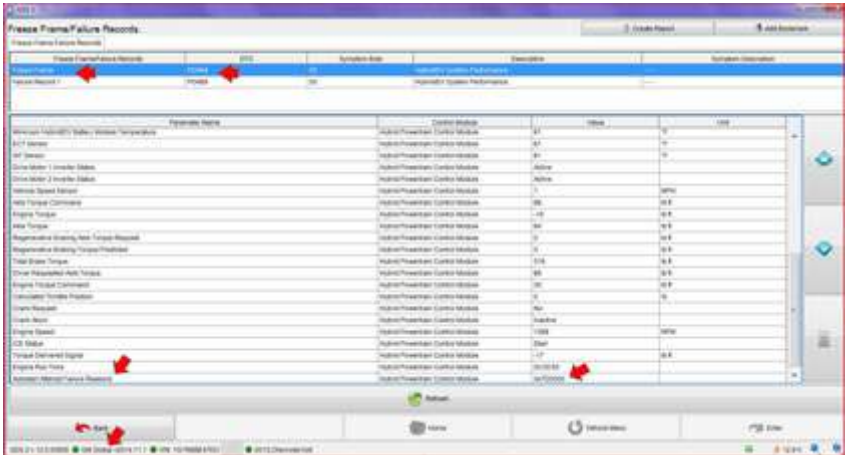
- 1) Review all modules for DTCs using GDS2 and select "Vehicle Wide DTC Check With Module Info" under the Vehicle Diagnostics Menu. DO NOT clear any DTC's. Review the HPCM and ECM Freeze Frame Data, then create a report. You can save the report or email it after doing so.
- 2) The HPCM Freeze Frame and Failure Records will include "Autostart Attempt Failure Reasons". In order to view them in the Freeze Frame Record, GDS2 must be updated to v12.0.0.00835 - Global v2014.11.1 or later.
