# Technical Service Bulletin

## 01 MIL on, DTC P218100, P017B00, P308100, and/or P01E400 are stored in the ECM

01 20 65 2058767/5 June 8, 2020. Supersedes Technical Service Bulletin Group 01 number 20-63 dated May 18, 2020 for reasons listed below.

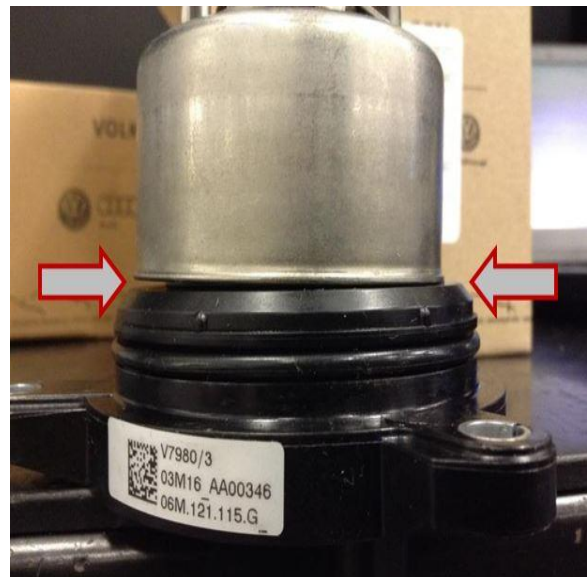
1. Remove the thermostat and check whether it closes completely. If the coolant is still warm, put the thermostat in cold water to restore its original condition. If there is a gap between chamber and seal, the thermostat is faulty and needs to be replaced.
2. Attach photos to the repair order which clearly shows that the thermostat does not close neatly.

*Figure 1. Gap between chamber and seal.*

After the repair, fill with G12evo coolant in the coolant circuit.
