## STAR ONLINE PUBLICATION

**Case Number:** S1925000008

**Symptom/Vehicle Issue:** Malfunction Indicator Lamp (MIL) Illumination. Diagnostic Trouble Codes (DTCs) P20E8 – Reductant Pressure Too Low and/or P208B – Reductant Pump 1 Control Performance Set.

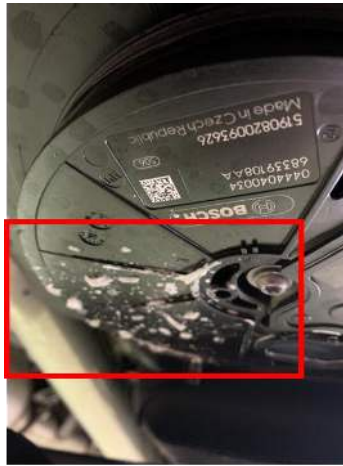
Figure 1.

2. Closely inspect the DEF supply line connections at the pump and injector to ensure there are no leaks. Look for signs of wetness, and/or crystallization around the connections indicating a leak. Please see (Figure 1, and 2.). Repair any leaks before proceeding with the rest of this procedure.
