**NUMBER:** 09-008-20

Inspect Hydraulic Belt Tensioner

2020 (DT) RAM 1500 Pickup

**NOTE:** This bulletin applies to the following vehicles built on or after December 13, 2019 (MDH 1213XX) on or before January 25, 2020 (MDH 0125XX) equipped with a 3.6L V6 24V VVT E-torque Engine Upgrade I (Sales Code ERG).

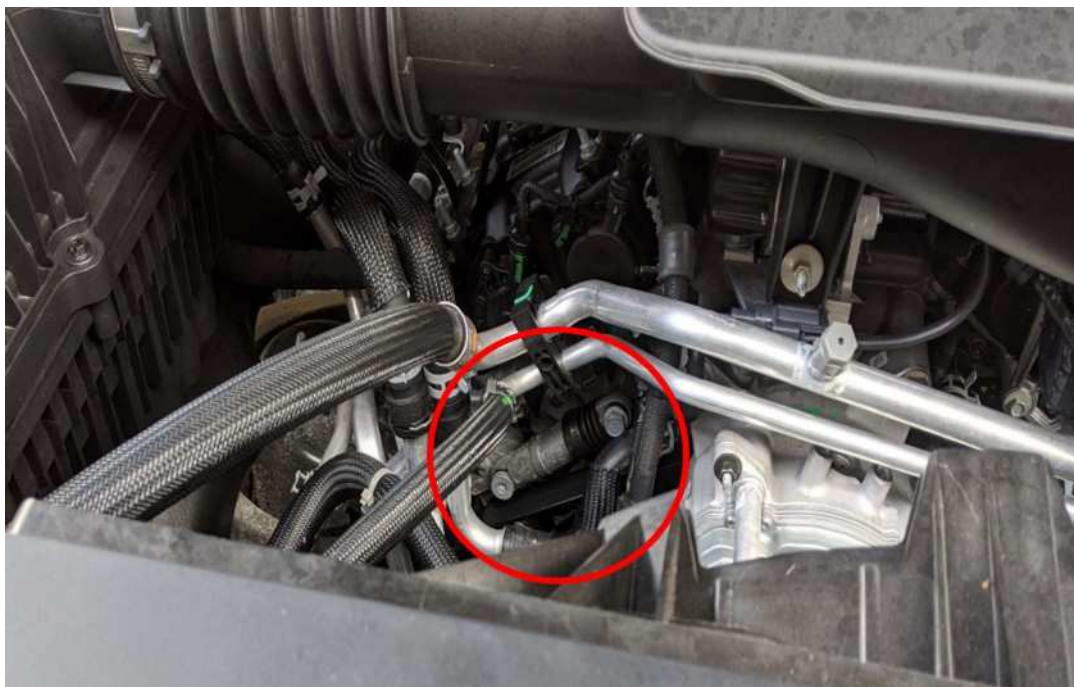
**Fig. 2**  
**Hydraulic Belt Tensioner**

1. Replace the hydraulic belt tensioner. Refer to the detailed service procedures available in DealerCONNECT/Service Library under: Service Info>07 - Cooling / Accessory Drive / Tensioner, Belt / Removal and Installation (Fig. 2) .
2. Clear any DTCs that may have been set.
