# Service Bulletin

Bulletin No.: 20-NA-099

**Subject:** Park Assist Not Available to Turn On or Off and Possible Driver Information Center (DIC) Illuminated with DTC U0159 Set

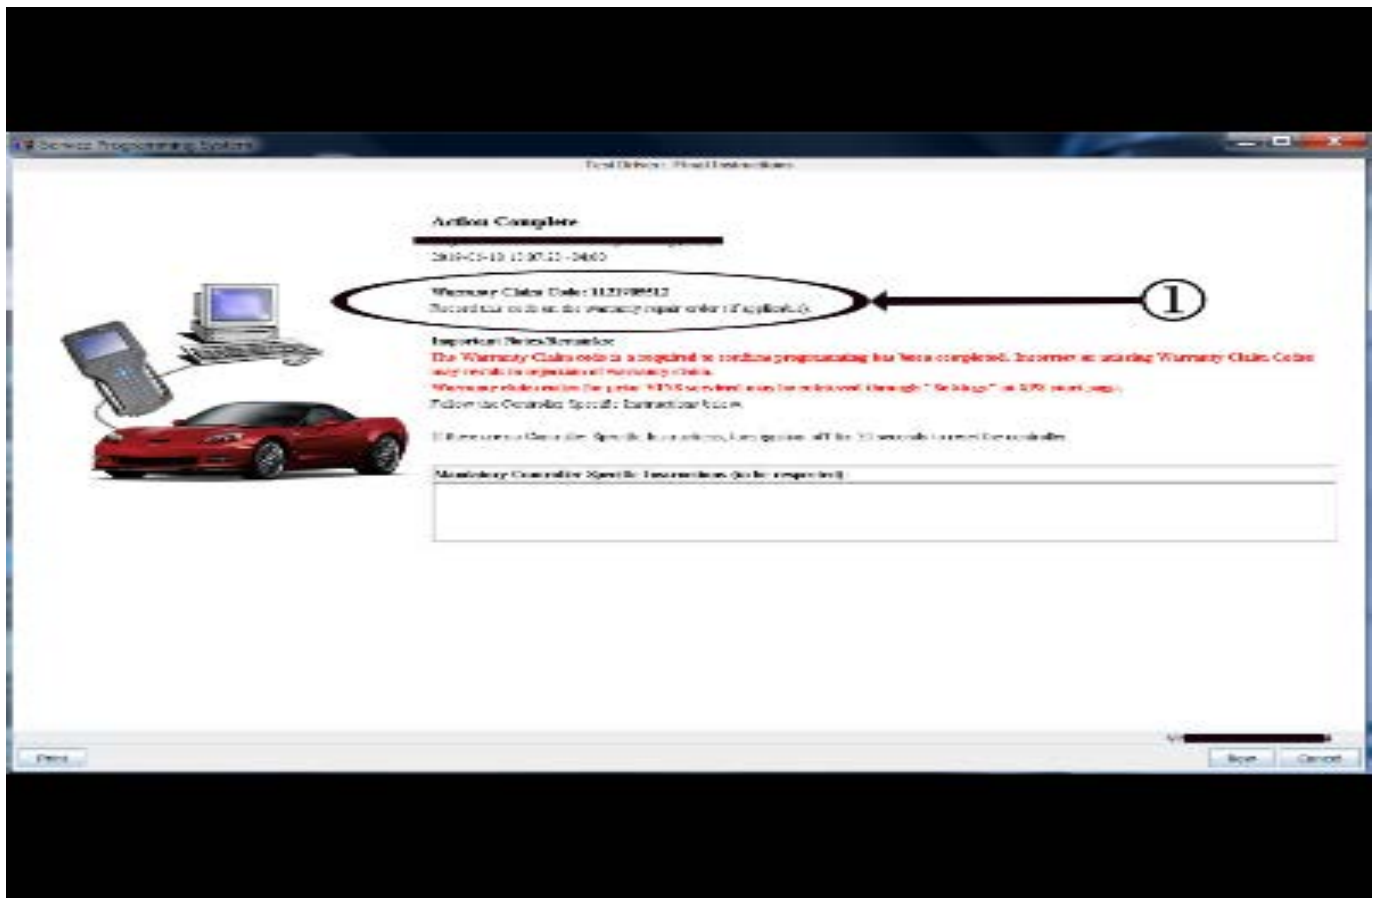
5431209

Important: To avoid warranty transaction rejections, you MUST record the warranty claim code provided on the SPS Warranty Claim Code (WCC) screen on the job card. Refer to callout 1 above for the location of the WCC on the SPS screen.

- 2. Record the SPS Warranty Claim Code on the job card for warranty transaction submission.
