# Service Bulletin

Bulletin No.: 20-NA-109

Subject: Malfunction Indicator Lamp (MIL) Illuminated - DTC P0128 Set

| Brand: | Model: | Model Year: | | VIN: | | Engine: | Transmission: |
|---|---|---|---|---|---|---|---|
| Cadillac | CT6 | 2019 | 2020 | - | - | 4.2L (LTA) | - |

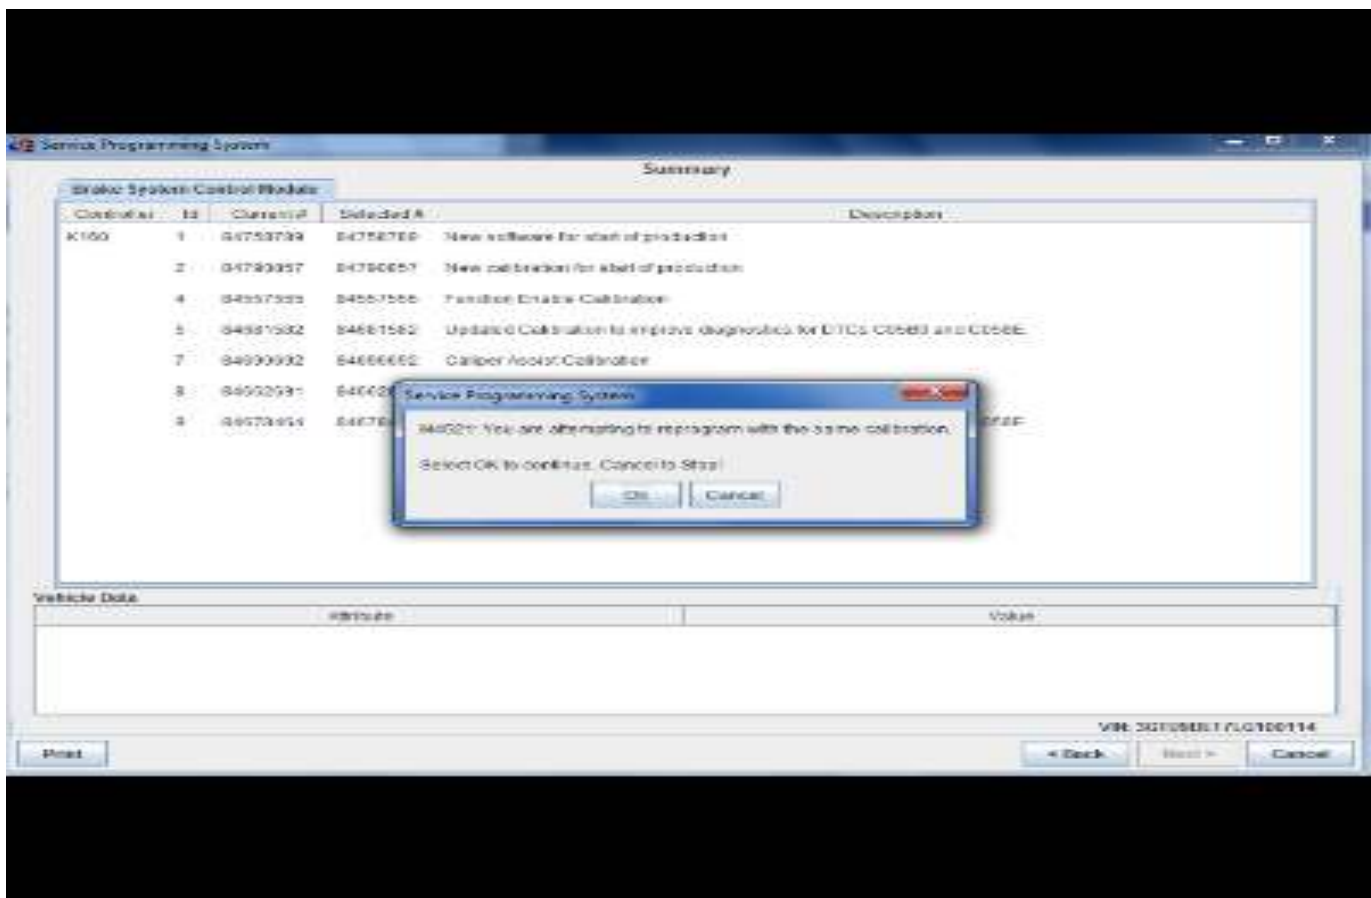
5431207

Important: TIS2WEB screen shown. Techline Connect screen is similar and will be included soon.

Important: If the Same Calibration/Software Warning is noted on the SPS screen, select OK and follow screen instructions. After a successful programming event, the WCC is located in the Service Programming

1. Reprogram the Engine Control Module. Refer to *K20 Engine Control Module: Programming and Setup* in SI. Modify as required (e.g., select x module from the controller screen). Then provide step-by-step instructions or refer to SI procedure.

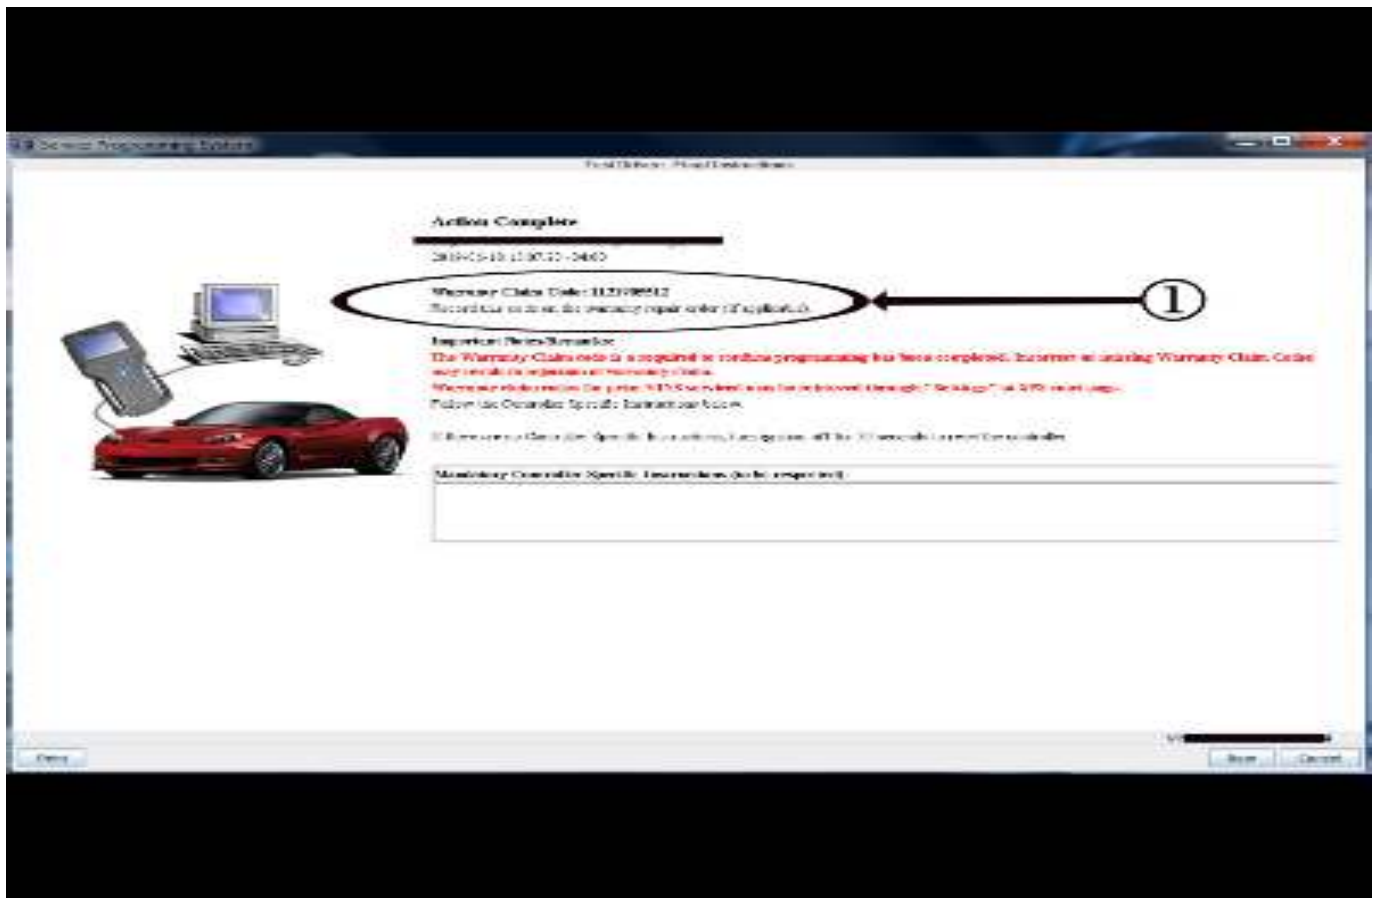
5431209

Important: TIS2WEB screen shown. Techline Connect screen is similar and will be included soon.

Important: To avoid warranty transaction rejections, you MUST record the warranty claim code provided on the SPS Warranty Claim Code (WCC) screen on the job card. Refer to callout 1 above for the location of the WCC on the SPS screen.

- 2. Record the SPS Warranty Claim Code on the job card for warranty transaction submission.
