# Technical Service Bulletin

## 39 Four-wheel drive malfunction message, DTC C05ED00 stored in the all-wheel drive control module

39 20 32 2051558/3 June 17, 2020. Supersedes Technical Service Bulletin Group 39 number 20-27 dated March 20, 2020 for reasons listed below.

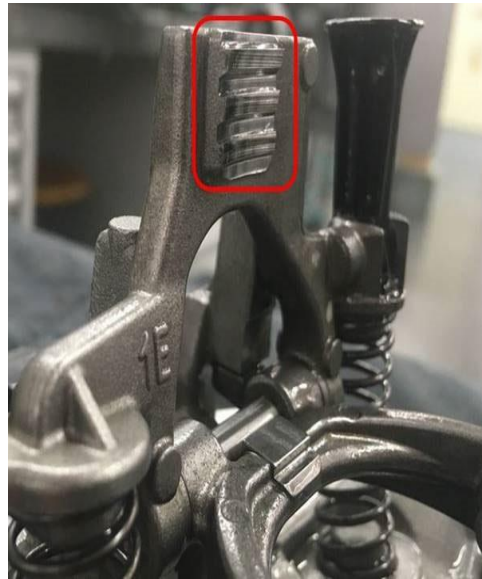
**Figure 1.** Worn/faulty shift fork.

Quattro Ultra shift fork inside the rear differential is worn/faulty (Figure 1).

Improved material in production

Complete the ODIS test plan for the **DTC C05ED00** (4WD/AWD Clutch "B" Stuck Engaged) completely according to Guided Fault Finding to rule out other reasons for the restricted function and to avoid an unnecessary parts replacement:

- If the result of the test plan leads to a repair, follow the Guided Fault Finding repair advice and this TSB does not apply.
  - If the result of the test plan finds no defect, perform a short test drive. If the same DTC returns after the test drive with the same symptom, the shift fork inside the rear differential is at fault and must be replaced. Perform the repair as follows. Do **not** replace the complete differential.
1. Drain the oil of the rear differential according to the repair manual.
  2. Remove the rear differential per the repair manual.
