# Technical Service Bulletin

## 91 MIB2 High: Navigation data read error/reboots, DTC B126CF0 and/or B126CF1 stored in the information module

91 20 78 2057052/3 June 18, 2020. Supersedes Technical Service Bulletin Group 91 number 20-37 dated February 20, 2020 for reasons listed below.

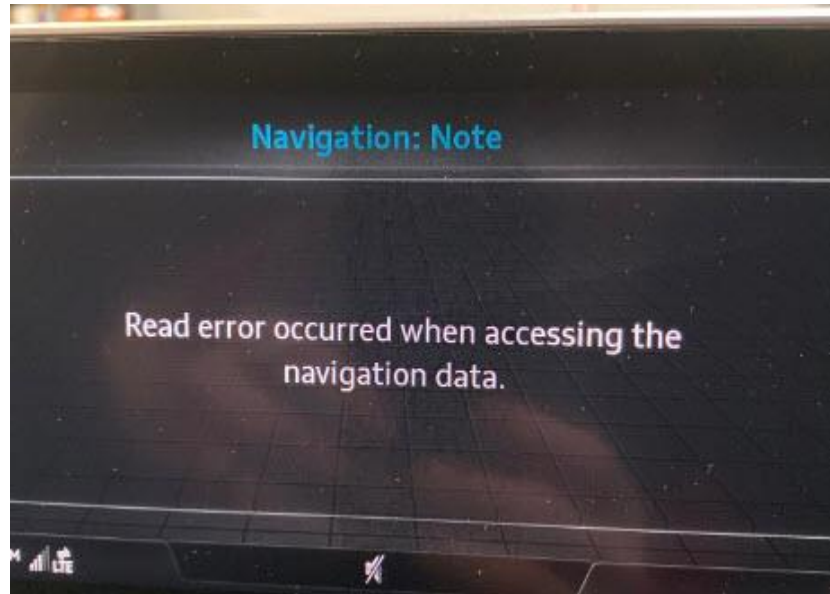
- The MMI shows the message “Read error occurred when accessing the navigation data” after initialization (Figure 1).
- The MMI reboots constantly.

**Figure 1.** The error message is shown on initialization.

If the navigation map database is corrupted during an online update, the message from Figure 1 is displayed and the navigation system is unavailable. The DTC B126CF0 is entered into the information electronics, J794 (address word 005F).
