# Service Update

## A202301230 Reduced Launch Performance

**Release Date:** May 2020

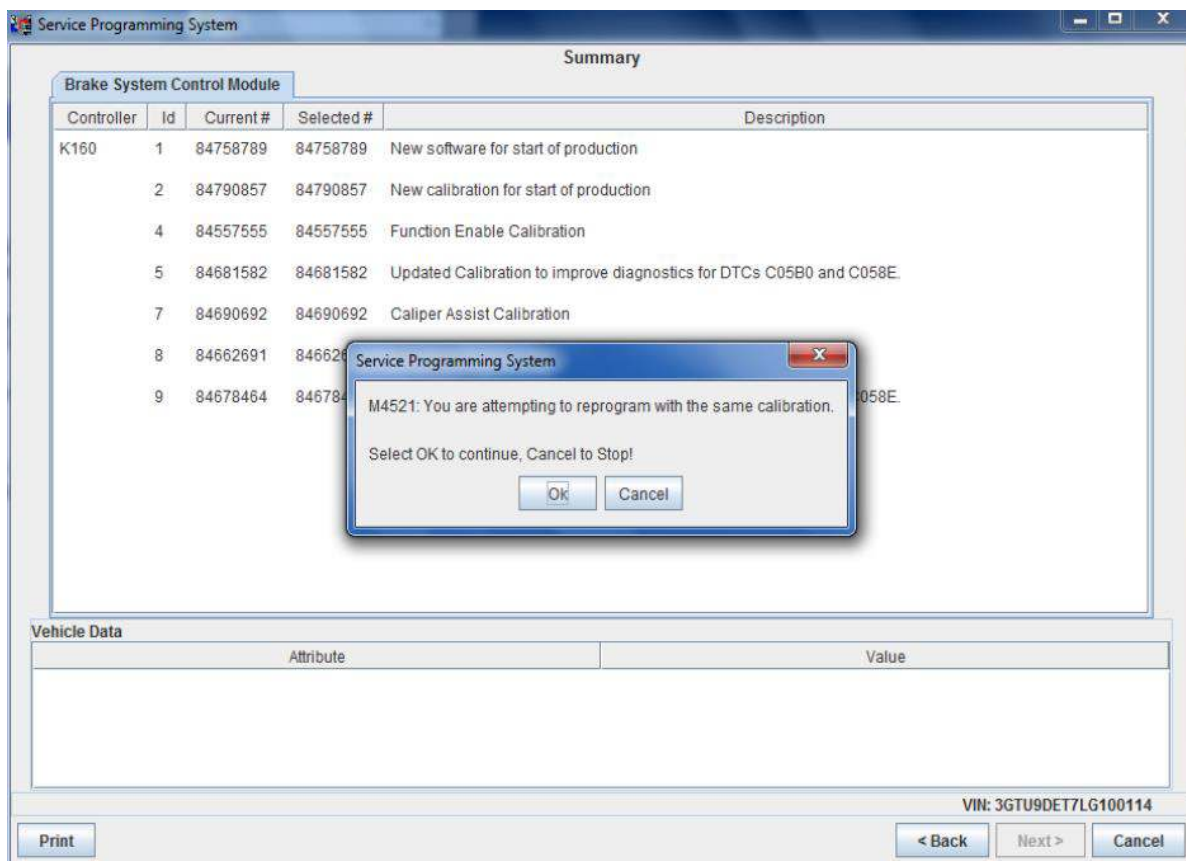
5431207

**Important:** If the Same Calibration/Software Warning is noted on the SPS screen, select OK and follow screen instructions. After a successful programming event, the WCC is located in the Service Programming System dialogue box of the SPS Summary screen. No further action is required. Refer to the Warranty section of the bulletin.

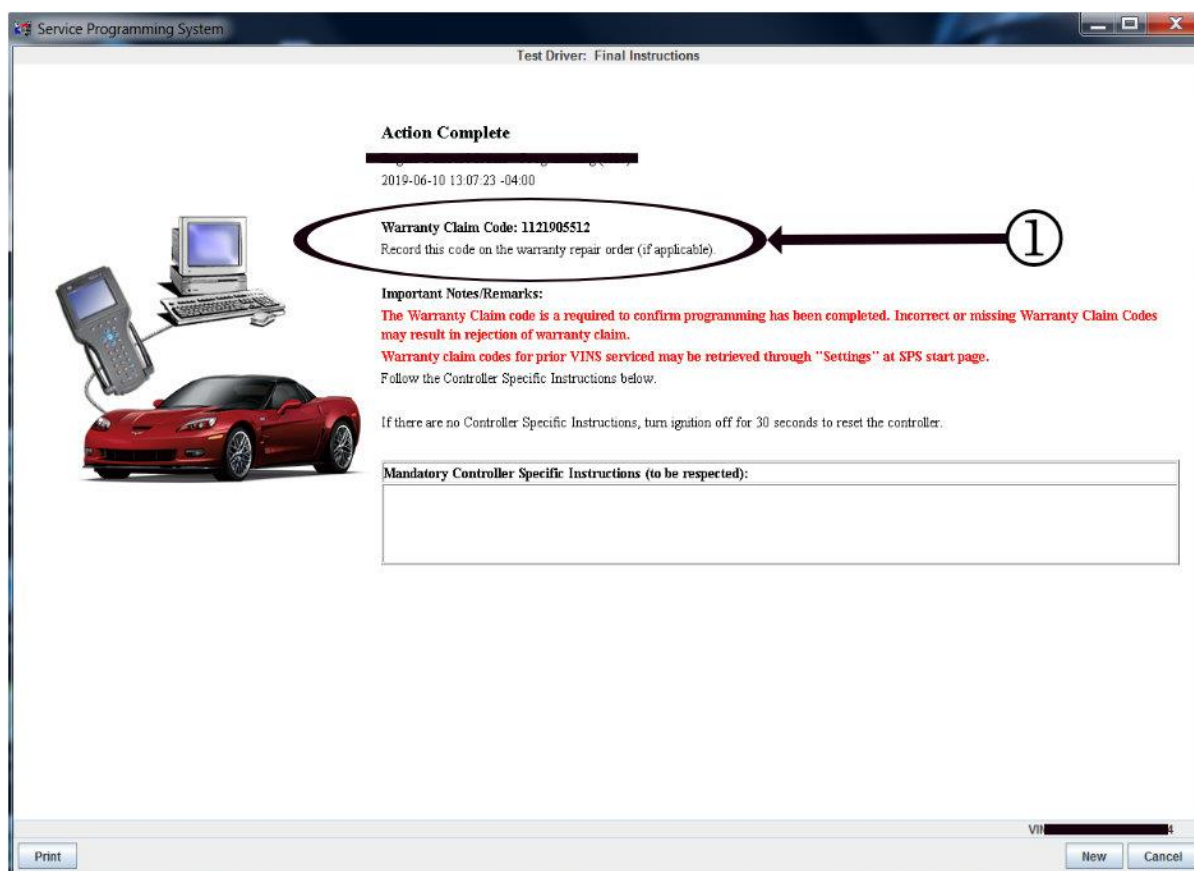
**Important:** To avoid warranty transaction rejections, you **MUST** record the warranty claim code provided on the SPS Warranty Claim Code (WCC) screen on the job card. Refer to callout 1 above for the location of the WCC on the SPS screen.

- Record SPS Warranty Claim Code on job card for warranty transaction submission.
