| <b>HYUNDAI</b><br><b>Technical Service Bulletin</b> | GROUP<br><b>CAMPAIGN</b> | NUMBER<br><b>20-01-027H</b> |
| | DATE<br><b>JUNE, 2020</b> | MODEL(S)<br><b>SONATA (DN8)</b> |
| <b>SUBJECT:</b> ECM SOFTWARE UPDATE – P030X & P0456 (SERVICE CAMPAIGN T5A) | | |

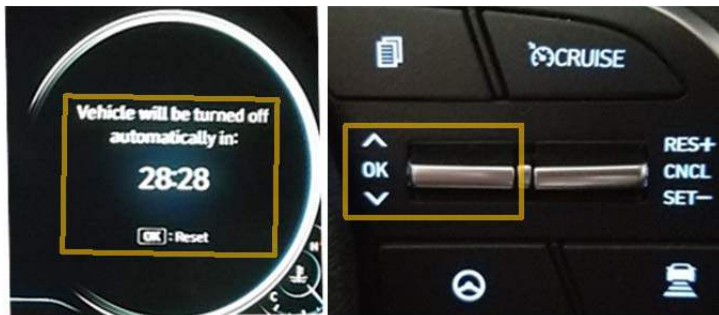
The ECM Software Update takes approximately 15 minutes to perform. However, the vehicle is equipped with a 30 minute factory default Vehicle Auto-Shut Off feature.

If the **Vehicle Shut-Off Timer: XX:XX** appears on the cluster, press **OK** on the steering wheel to reset the timer before starting the ECM update.

In the event of ECM update failure due to Vehicle Auto-Shut Off activation, perform the ECM update again in **Manual Mode**.
