GLOBAL SAFETY FIELD INVESTIGATIONS  
DCS5422  
URGENT - DISTRIBUTE IMMEDIATELY

Subject: A202302140-01 - Service Update  
Engine Oil Pressure Sensor Performance Error  
Revised Part, Warranty and Service Procedure sections

Models: 2020 Buick Encore GX  
2021 Chevrolet Trailblazer  
Equipped with 1.2L Turbo Engine (RPO LIH)

## A202302140 Engine Oil Pressure Sensor Performance Error

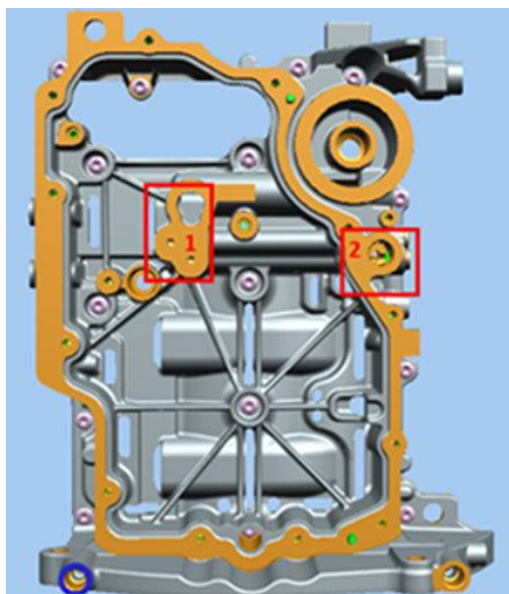
5617448

| <b>Condition</b> | On certain vehicles, the engine oil pump may be stuck due to foreign material, and diagnostic trouble codes (DTC) P0521, P06DE, P06DD could be set. |

**Caution: Ensure the three oil pump oil holes (Area 1) and OCV mounting hole (Area 2) are free of debris BEFORE installing the oil pump and OCV. If debris is found, remove with a lint-free cloth or brush that will not scratch the surface.**
