# Service Update

## N202296490 Drive Motor Power Inverter Module

**Release Date:** June 2020

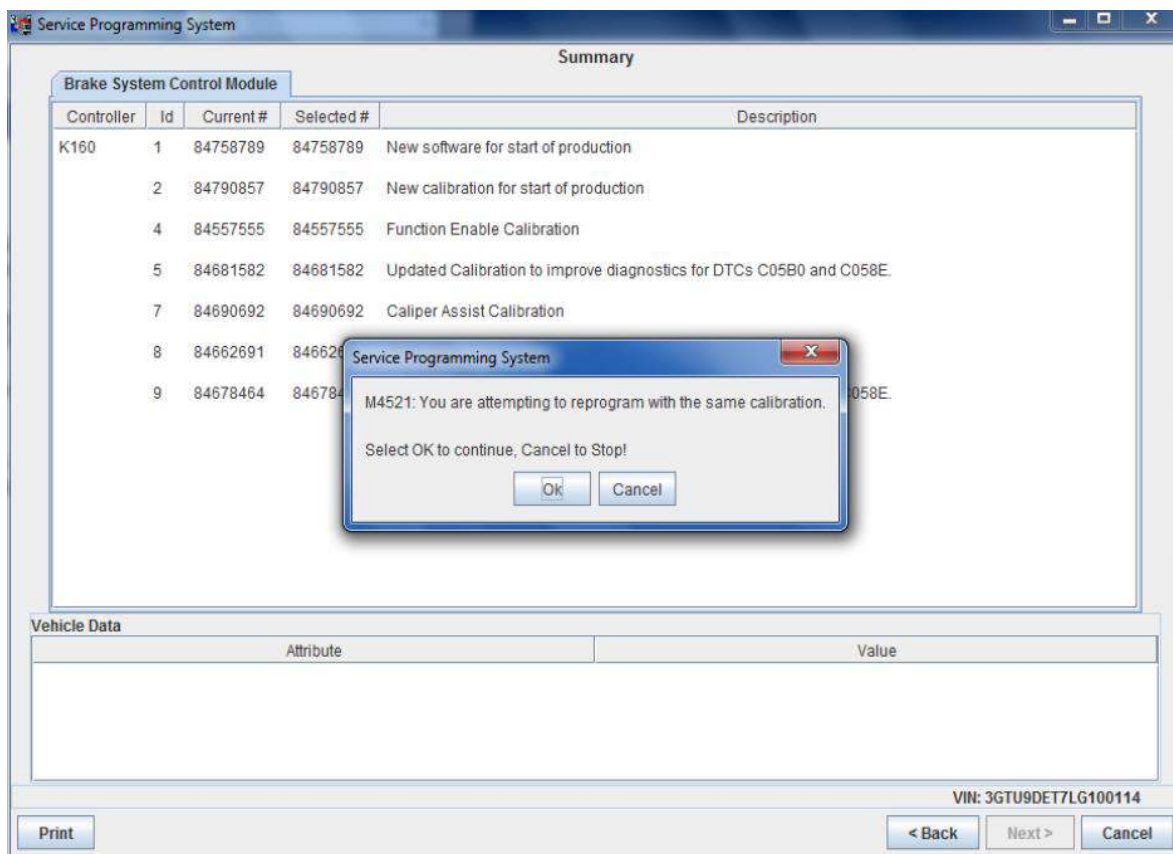
5431207

**Important:** TIS2WEB screen shown. Techline Connect screen is similar and will be included in the near future.

**Important:** If the Same Calibration/Software Warning is noted on the SPS screen, select OK and follow screen instructions. After a successful programming event, the WCC is located in the Service Programming System dialogue box of the SPS Summary screen. No further action is required. Refer to the Warranty section of the bulletin.

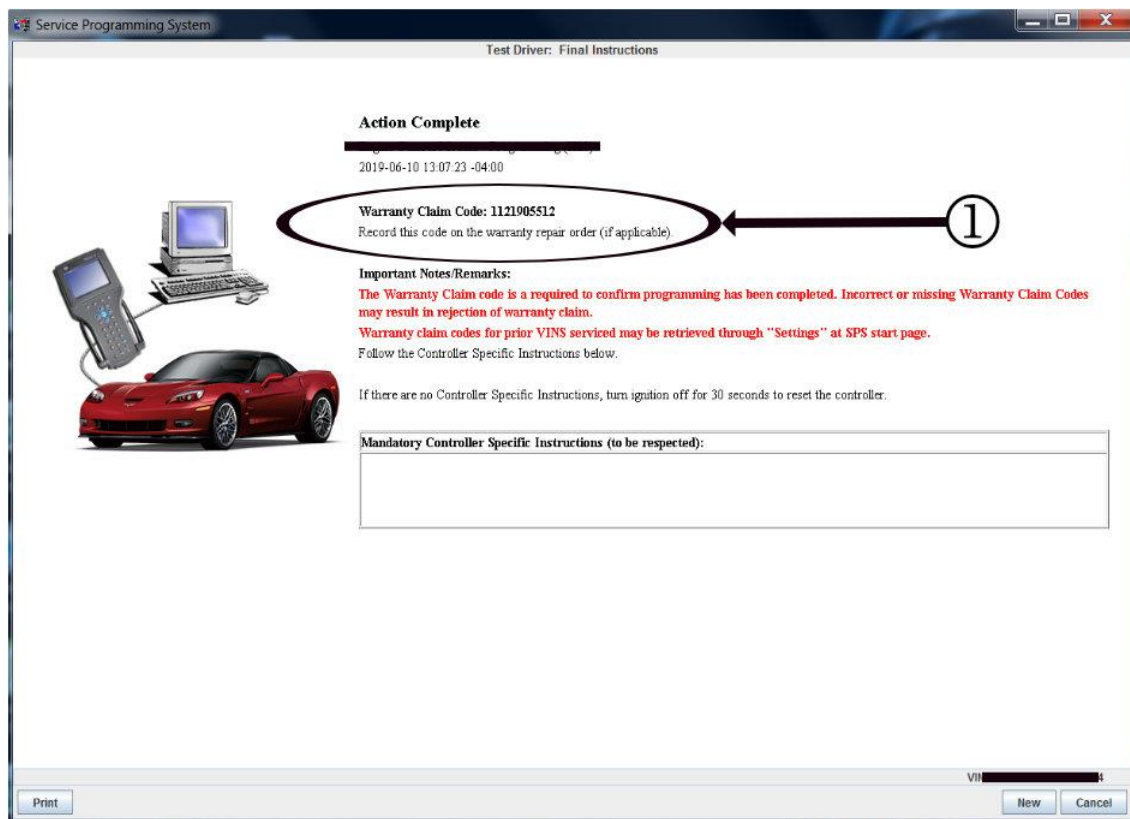
5431209

**Important:** TIS2WEB screen shown. Techline Connect screen is similar and will be included soon.

**Important:** To avoid warranty transaction rejections, you **MUST** record the warranty claim code provided on the SPS Warranty Claim Code (WCC) screen on the job card. Refer to callout 1 above for the location of the WCC on the SPS screen.

- Record SPS Warranty Claim Code on job card for warranty transaction submission.
