# Special Coverage Adjustment

## N182188250 Loss of Continuity within Accelerator Pedal Position Sensor Circuit

**Release Date:** August 2019

**Revision:** 02

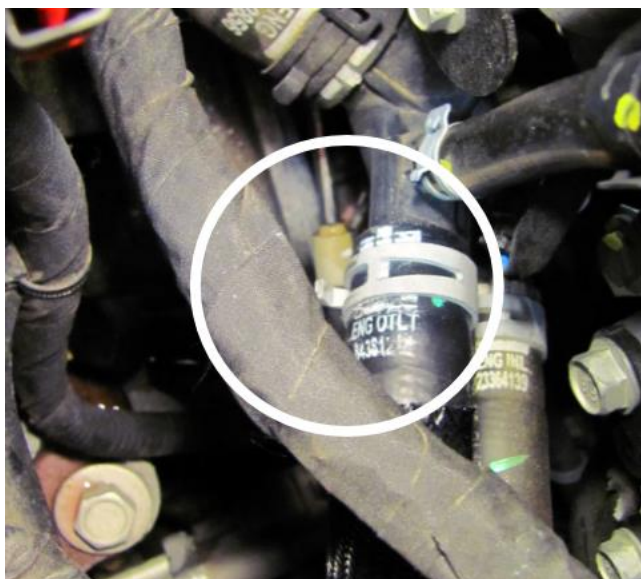
5309871

2. On Malibu (LFV engine) applications **only**, inspect the engine wire harness adjacent to the heater inlet hose for contact with the heater inlet hose clamp on the engine outlet portion of the hose as shown.

**Caution:** The heater hose clamp may be glued to the heater hose. If the clamp is glued to the heater hose, **do not** attempt to rotate the heater hose clamp, as heater hose damage may occur and clamp may have residual rubber material on it. Instead, replace the heater hose and both clamps.

3. If contact is observed between the heater hose clamp and the engine wire harness, attempt to rotate the heater hose clamp tabs away from the engine harness, ensuring the clamp stays within the alignment guide markings.

- If the heater inlet hose clamp is **not** glued to the heater inlet hose, rotate the heater inlet hose clamp so the tabs are facing away from the engine wire harness. Ensure the clamp stays within the alignment guide markings. There should be at least 3/4 inch (19mm) of clearance between the heater hose clamp tabs and the engine wire harness.

- If the heater hose clamp **is** glued to the heater hose, replace the heater inlet hose and both heater hose clamps, being sure to clock the heater inlet hose clamps so the tabs are facing away from any adjacent engine wire harnesses. Ensure the clamp stays within the alignment guide markings. Refer to *Heater Inlet Hose Replacement (LFV)* in SI.

- If any damage is observed to the engine harness, repair the harness and the affected circuits. Refer to *Wire to Wire Repair* in SI. Rewrap the harness in the affected area with PET tape in addition to clocking the hose clamp away from the harness to ensure another rub-through event is no longer possible.
