**NUMBER:** 09-009-20

Improperly Installed Exhaust Gas Recirculation (EGR) Valve

This bulletin involves removing and inspecting the vacuum tube, EGR tube gaskets, tube flange mounting bolts and possibly replacing the EGR tube gaskets and torquing the flange bolts.

2018 - 2019 (DS) RAM 1500 Pickup

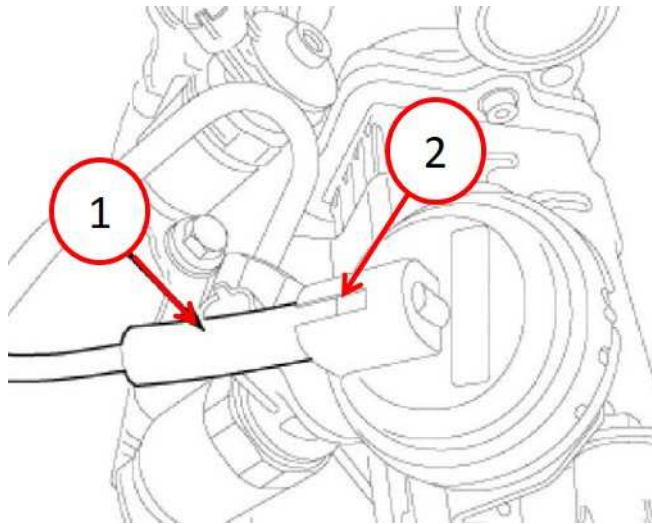
**Fig. 3**  
**Vacuum Tube And Vacuum Actuator**

- 1 - Vacuum Tube  
2 - Vacuum Actuator
-

4. Is the vacuum tube fully seated in the vacuum actuator (Fig. 3) ?
- YES >>> Proceed to [Step 5](#) of the Diagnostic Procedure.
  - NO >>> Fully seat the vacuum tube on the vacuum actuator. Proceed to [Step 5](#) of the Diagnostic Procedure.

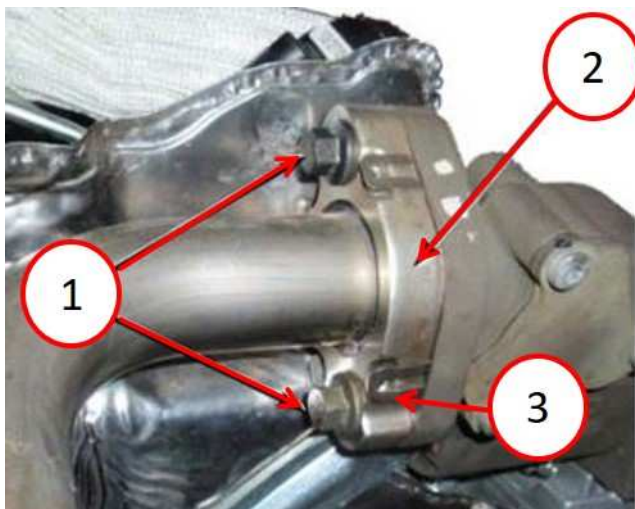
Fig. 4

5. Inspect both the upper and lower EGR tube gaskets (inlet – from turbo/outlet – to intake) that are mated to the EGR valve and that all gasket tabs showing on the **exterior of the tube flange** (Fig. 4) .
- Also inspect that all upper and lower EGR tube flange bolts are tight (Fig. 4) .

**Example Of Lower Tube Flange Bolts, Flange And Gasket Tabs (Upper Tube Similar)**

- 1 - Lower Tube Flange Bolts
- 2 - Lower Tube Flange
- 3 - Gasket Tabs Shown Properly Installed On Exterior Of Flange

**NOTE: If the EGR tube flange bolts appear tight, it is recommended all flange bolts be re-torqued.**

6. Is the either upper or lower EGR tube gasket damaged, missing, gasket flange tabs not showing or the flange bolts loose?
    - YES >>> Proceed to [Step 1](#) of the Repair Procedure.
    - NO >>> Proceed to [Step 7](#) of the Diagnostic Procedure.
  7. Re-torque all the tube flange bolts to 25 N·m (18 ft. lbs.).
  8. Install the fuel injector silencer and engine cover. Refer to the detailed service procedures available in DealerCONNECT/Service Library under: 09 - Engine, 3.0L Turbo Diesel/Cover, Engine/Installation.
- This bulletin has been completed, use inspection LOP (25-01-43-90) to close the active RRT.

3. Clean surface and install the upper EGR intake air tube using a new tube to EGR gasket, with gasket tabs bent over on the exterior of the flange ([Fig. 4](#)) . Refer to the detailed service procedures available in DealerCONNECT/Service Library under: Service Info>25 - Emissions Control/Exhaust Gas Recirculation, Diesel/Tube, Exhaust Gas Recirculation (EGR)/Installation.

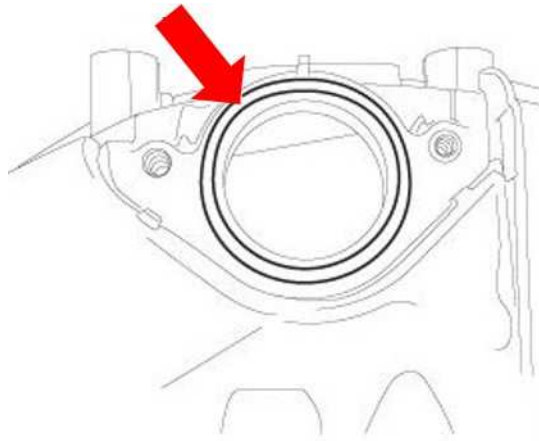
**Fig. 5**

**Re-Use Rubber Upper Tube To Intake Gasket**

**NOTE:** Do not discard the rubber upper tube to intake gasket ([Fig. 5](#)) . This rubber gasket is to be re-used.
